Patriot Home Inspections, LLC  
239-826-5866

Nick Brugal, FL State License #HI9057

**Type of Building :** Single Family

**Year of Construction:** 1990

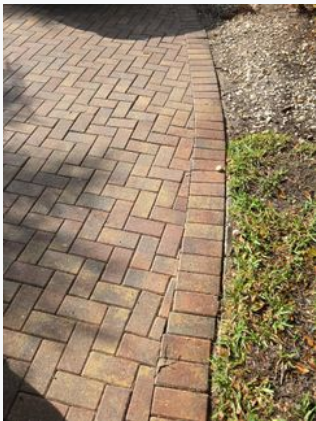
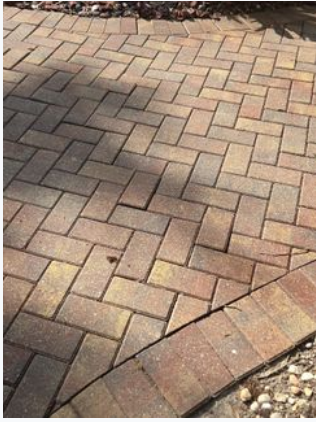
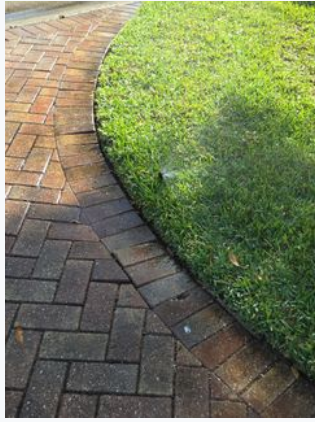
- (E-1) Defects:** Elevation changes and lifting were noted in the pavers at the right side of the home. This appears to be the result of movement in the underlying base material.
- Areas of uneven, lifted, and separated pavers were noted at the driveway in multiple locations.

- Elevation changes and lifting were noted in the pavers at the right side of the home. This appears to be the result of movement in the underlying base material.
- Areas of uneven, lifted, and separated pavers were noted at the driveway in multiple locations.

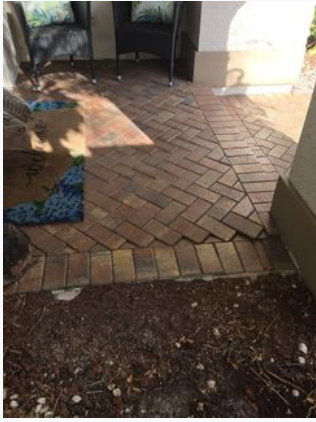
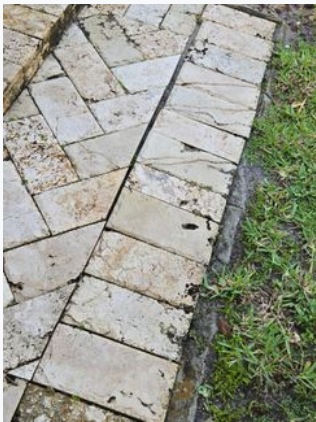
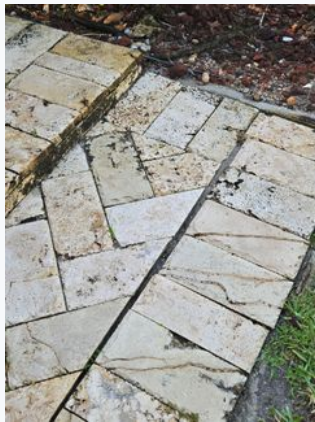
- (E-2) Defects:** Some of the pavers at the front entryway were uneven with elevation changes. This appears to be the result of soil movement.
- Separation of the pavers was noted at the ground-level landing at the right side of the home with retention mortar failure.

- Some of the pavers at the front entryway were uneven with elevation changes. This appears to be the result of soil movement.
- Separation of the pavers was noted at the ground-level landing at the right side of the home with retention mortar failure.

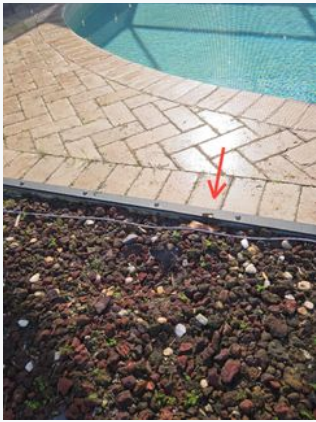
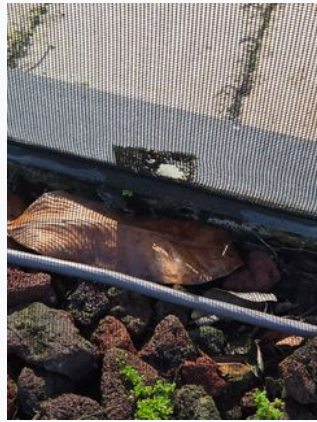
### (E-3) Defects: Screening

- Screen damage (minor - cut / puncture / etc)

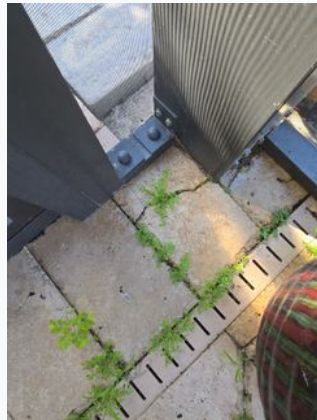
#### (E-4) Defects: Pool Patio

- A large number of weeds were noted in the joints of the pavers. This is a maintenance issue.
- One cracked tile noted at the left rear patio door.

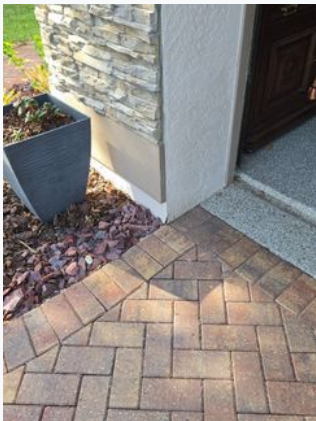
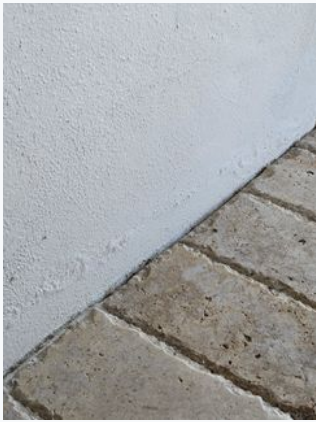
**(E-5) Defects:** Rusting and separation were noted at the metal corner beads behind the stucco

- Paint separation and bubbling were noted at the base of the wall to the right of the garage door, suggesting water exposure at this area.
- Hairline stucco cracking noted at multiple walls. *This condition is commonly associated with normal material shrinkage or minor movement.*

- Patterned cracking noted (step, diagonal, etc), suggesting localized stress from past movement. *This type of cracking is commonly associated with normal material behavior at transitions or concentrated points. Directing water away from the home with gutters and downspout extensions is recommended.*

- The half-wall concealing the trash cans shows signs of material failure, stucco separation, and corner bead rusting/deterioration.
- Multiple areas of stucco separation and corner bead deterioration were noted at the back patio walls near the sliding glass doors and tracks.

- Areas of paint separation noted at the back patio wall.

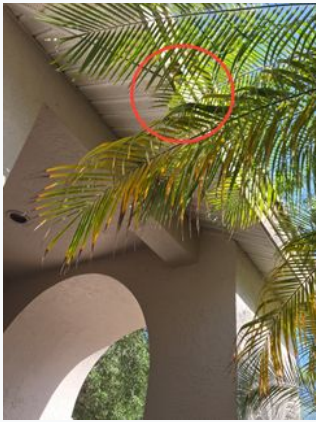
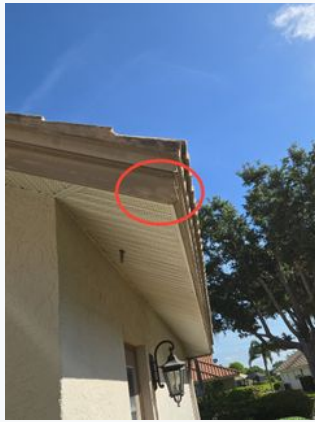
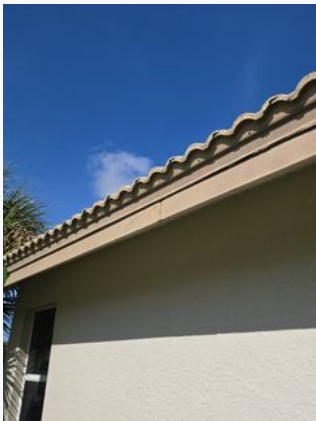
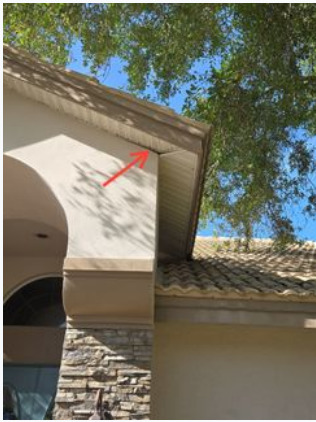
**(E-7) Defects:** Multiple areas of fascia board rot were noted at sides of the home. Further evaluation and correction of the fascia system recommended.

- The soffit near the front entrance of the home has a gap/break. This condition can allow pest intrusion.
- Damage/rot noted in the wood structure of the patio screening at the right side of the home.
- Multiple areas of fascia board rot were noted at the left side of the home. Evaluation was limited to visible areas only. Further evaluation and correction of the fascia system recommended.

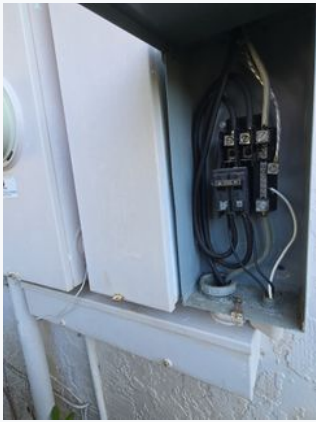
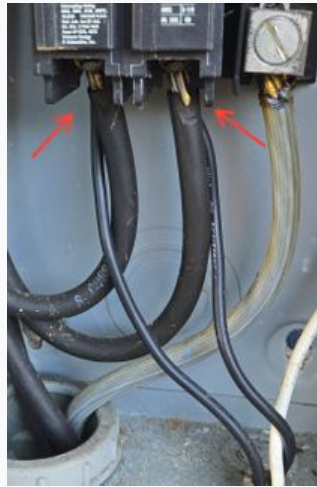
**(E-8) Defects:** The 100-amp subpanel/disconnect located next to the utility meter has been double-tapped with the surge protector wiring. Multiple conductors under a terminal not rated for more than one conductor can result in a loose connection and overheating. Correction recommended.

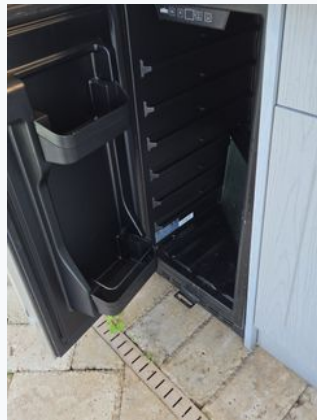
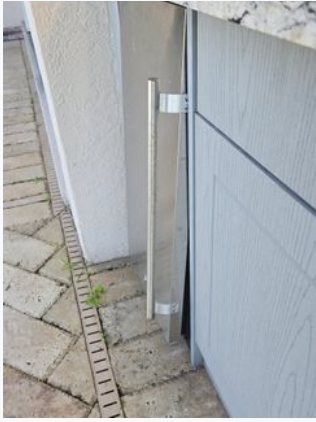
### (E-9) Defects: Built-in Outdoor Kitchen

- One cabinet door was not properly installed.
- The mini fridge was not level and was not operational at the time of inspection.

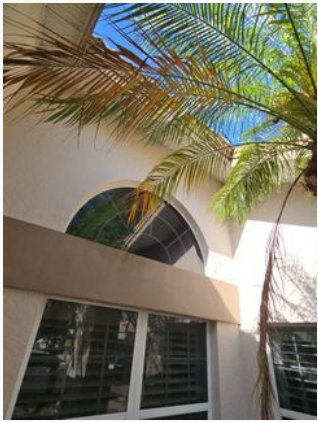
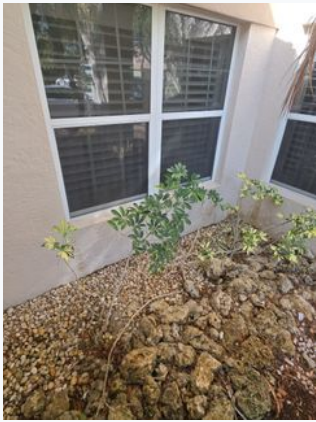
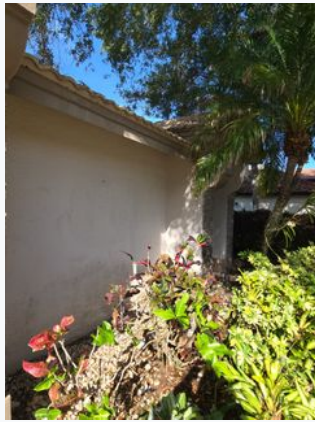
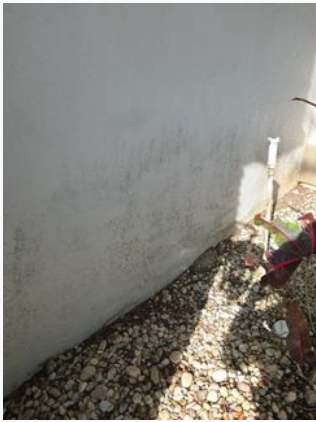
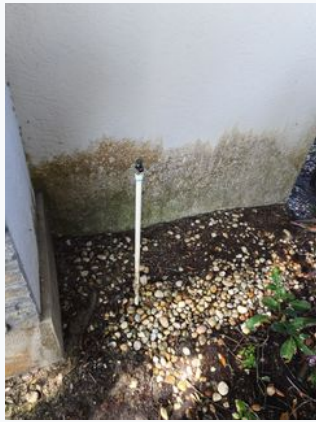
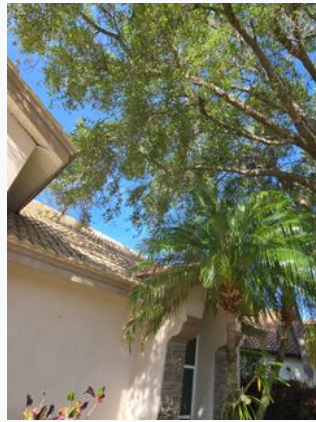
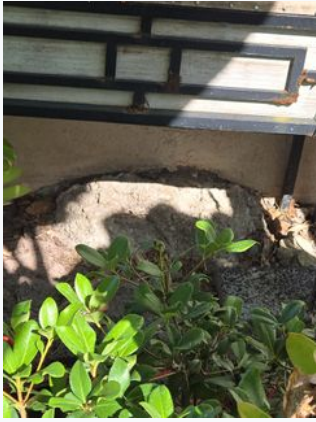
**(E-10) Defects:** Due to the roof design some areas do not have gutters resulting in rainwater discharging directly to the ground below, causing splashback at the wall. Rock has been installed in this area to reduce erosion and water splash. This is not considered a functional defect, but noted for your information.

- A large oak tree at the front right side of the home has branches contacting the roof and roots interacting with the driveway. Trimming of the branches and evaluation of the root interaction is recommended.
- At the left-back side of the home, an area of erosion and a pile of concrete were noted against the wall with stucco differences. The reason for this condition is unknown. Further investigation warranted.

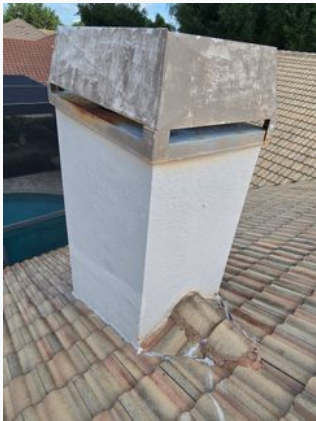
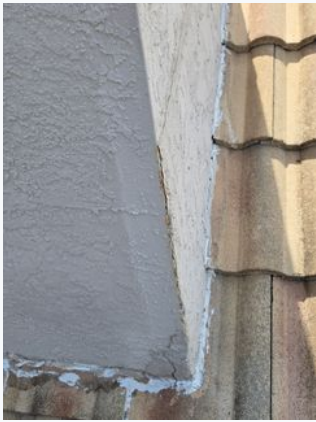
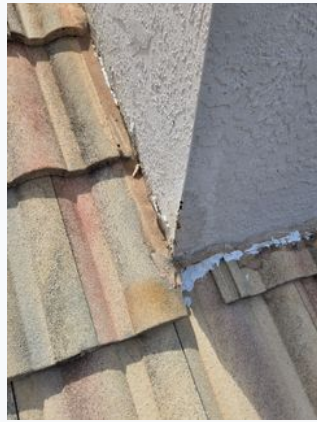
**(E-11) Defects:** The stucco around the chimney shows prior repair with continued deterioration. Chimneys are common leak points. Correction recommended.

- Rusting was noted at the vent cap. Ongoing corrosion can lead to deterioration and leaking.

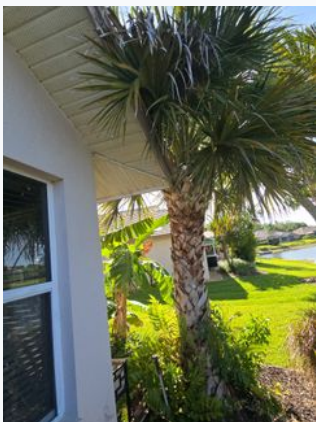
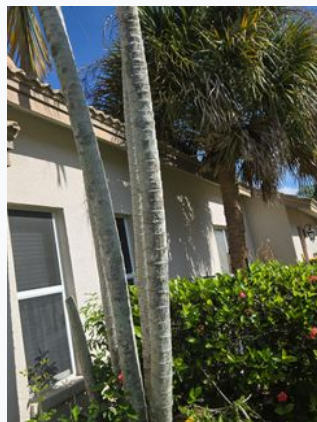
### (E-12) Defects: Trees / Plants

- Plants come in contact with the exterior wall. All plants should be cut back at least one foot from the wall as a best practice.
- Tree branches overhanging the roof surface. Overhanging branches can provide a pathway for rodents and other pests to access the attic. It is recommended to trim all tree branches at least 2 feet away from the roofline.

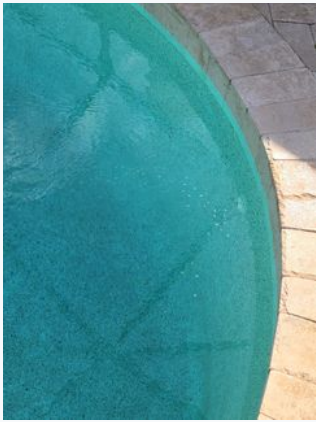
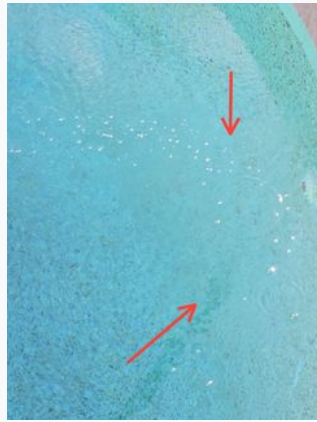
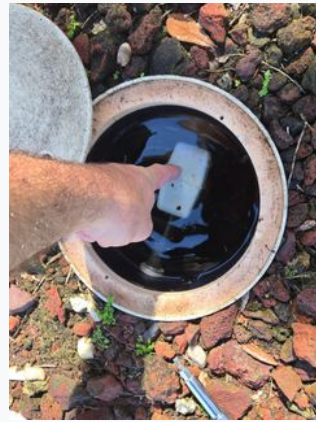
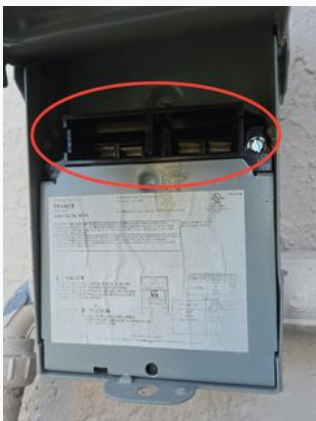
- The pool heater was disconnected at the disconnect box. The pull-out handle/bar required to energize the disconnect was missing. The pool heater was not tested and functionality is unknown.

- Air bubbles were observed at one or more pool inlets. *This condition is typically associated with air entering the system on the suction side, commonly at the pump, fittings, or valves.*

- Auto-fill system did not operate during testing.

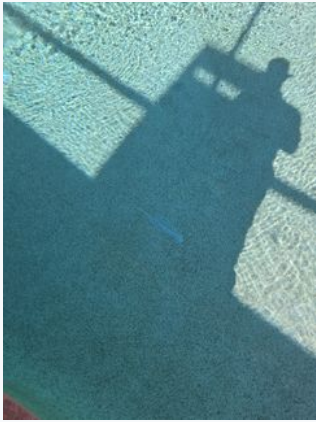
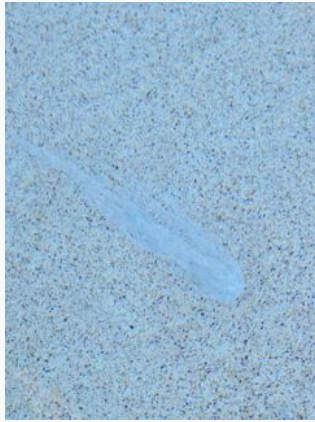
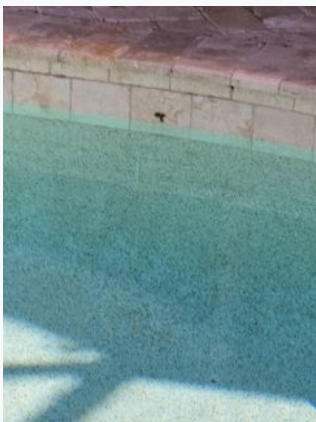
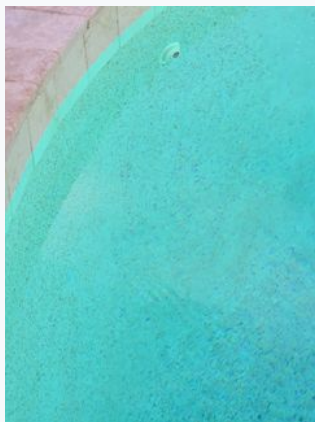
### (E-15) Defects: Walls

- Mineral deposits consistent with calcium scaling were observed on the pool/spa surface. *This is typically a cosmetic condition related to water chemistry and maintenance; however, professional evaluation by a pool specialist is recommended.*
- Heavy calcium buildup was noted on the pool surface. The buildup exceeds typical minor surface scaling and may require professional cleaning or treatment. Further evaluation by a pool professional recommended.

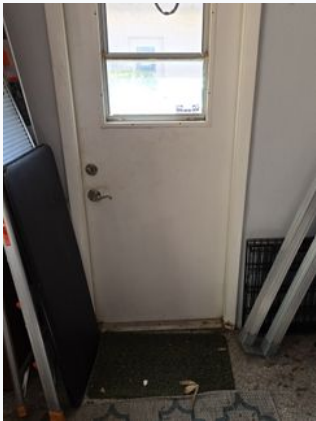
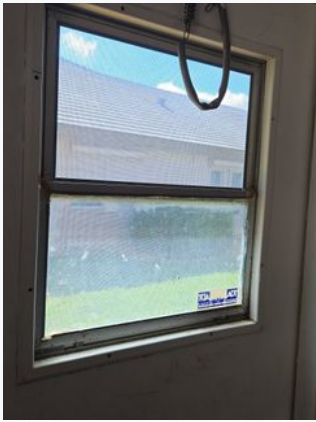
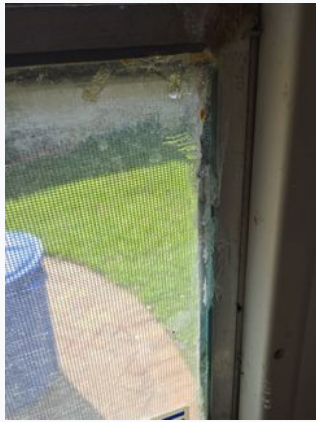
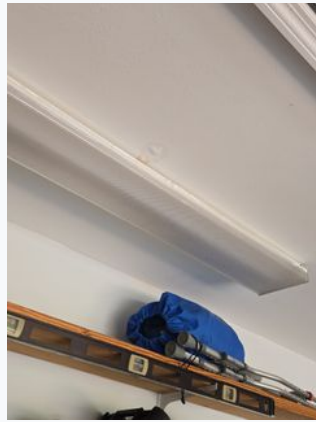
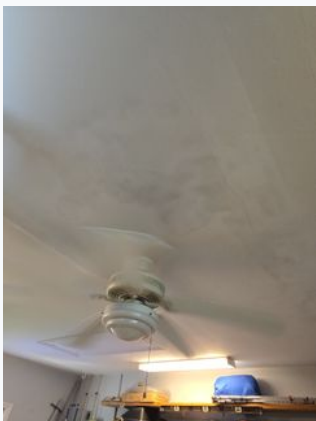
- (I-1) Defects:** Wood rot at the garage side door frame and rusting at the door were noted, indicating prolonged water exposure and water entry.
- The window at the side entry door has been hot glued in place. This is not an appropriate installation/repair method.
  - An area of water staining was noted on the ceiling near the light fixture. The area appears to have been previously patched and has reemerged. The area was dry at the time of inspection.
  - One light did not function.
  - The ceiling beneath the air handler shows prior patching, with water staining observed at the unit consistent with past moisture issues at the air handler.

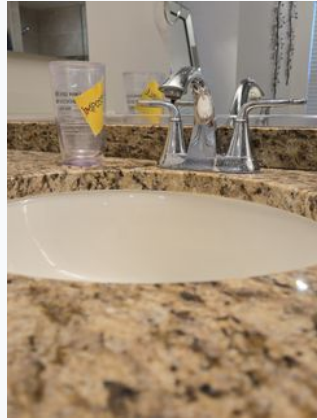
**(I-3) Defects:** The toilet was loose / not properly secured to the floor.

- Multiple windows showed water staining at the frame assemblies, consistent with intrusion at these locations.
- Corrosion buildup noted at both sink drain junction points, consistent with seepage at the connections.
- Corrosion noted at the left sink faucet, consistent with ongoing water exposure at the fixture, likely due to internal leak / failure.
- Water staining / damage at the exterior wall adjacent to the shower. This is consistent with

- Surface finish deterioration noted at the tile.

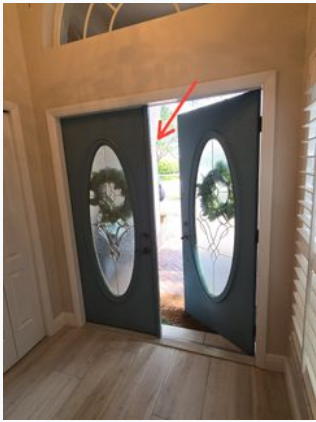
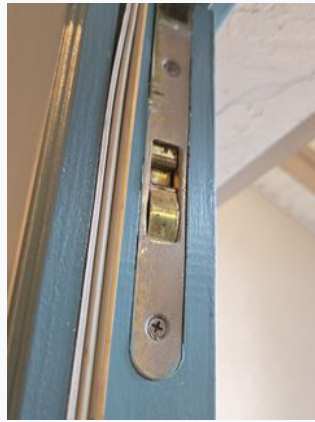
**(I-4) Defects:** The pin lock at the support French door does not disengage.

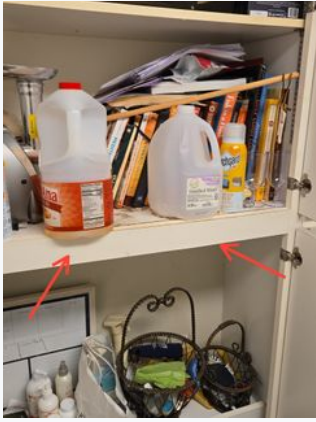
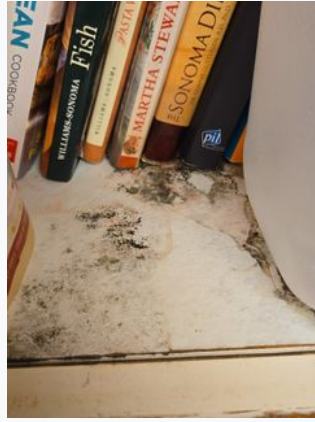
**(I-5) Defects:** Microbial growth was noted inside the cabinetry, consistent with moisture exposure from a stored water container. As a licensed mold remediation professional, the inspector notes that industry standards (IICRC) call for controlled containment and professional remediation, as improper removal can spread spores.

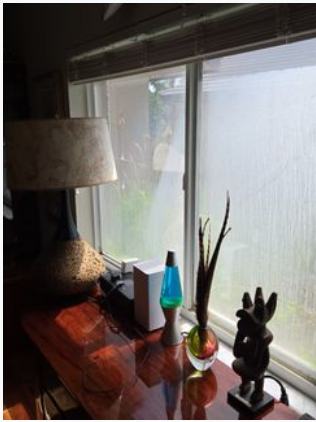
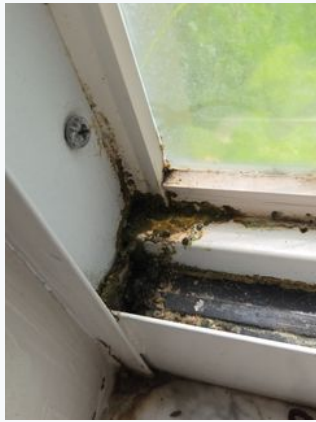
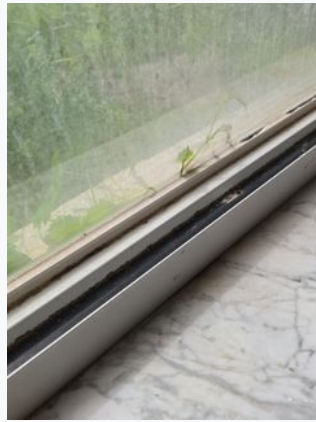
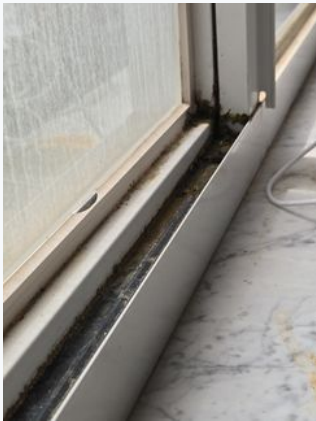
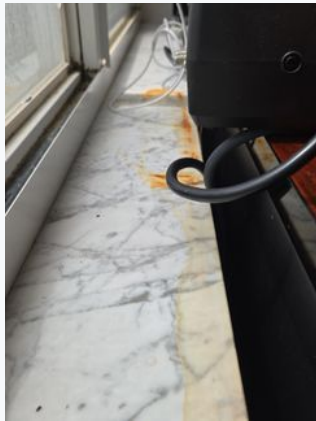
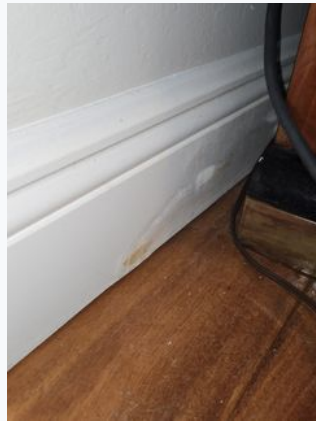
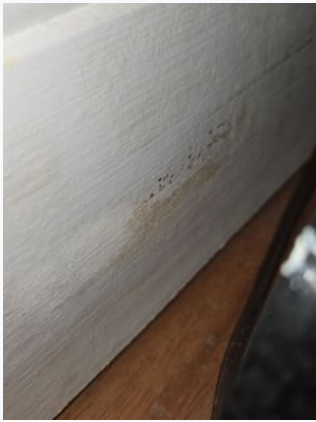
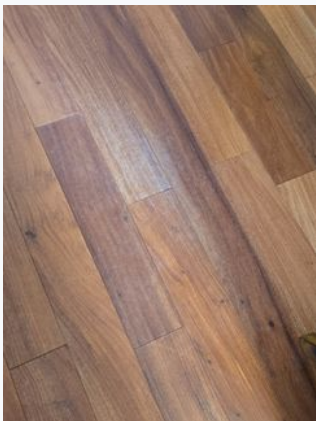
- (I-6) Defects:** Water intrusion was noted at the window assembly, with interior leaking present. Water staining, microbial growth, and baseboard deformation were observed beneath the window, indicating damage from this condition and possible concealed growth within the wall cavity.
- Surface wear noted on the flooring.

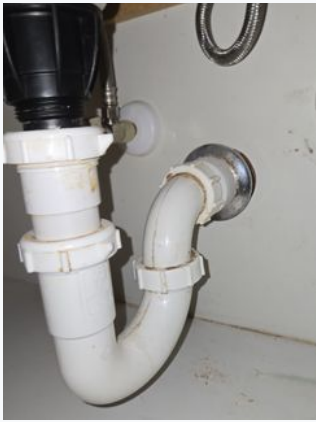
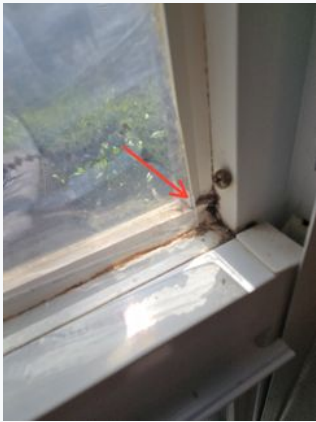
- (I-7) Defects:** Buildup at drain junction points, consistent with minor seepage at the joints.
- Water staining was noted at the window assemblies, consistent with intrusion at these locations.

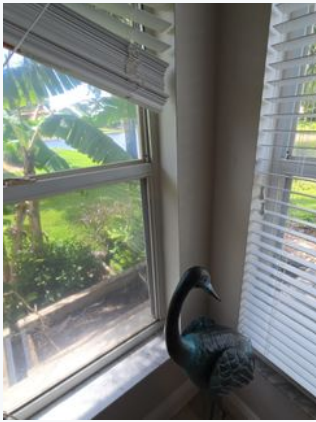
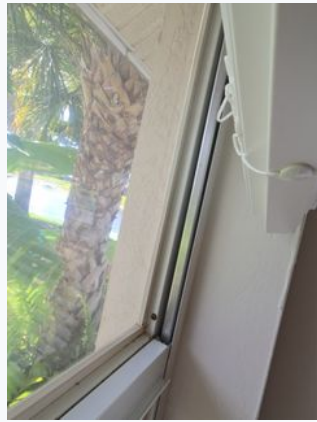
**(I-8) Defects:** The windows displayed multiple defects, including balances out of place, damaged integrated trim, and water staining at the assemblies consistent with intrusion.

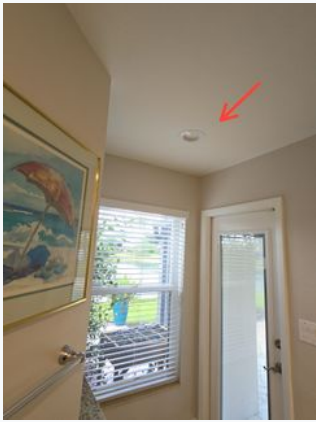
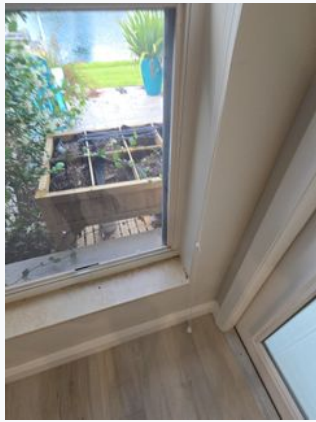
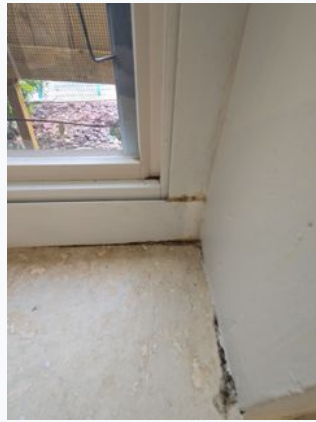
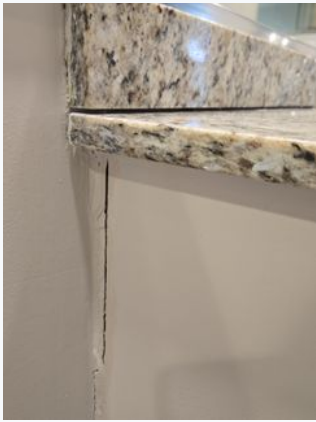
**(I-9) Defects:** The light near the patio door did not function.

- Water staining was noted at the window assembly with damage to the adjacent drywall, consistent with intrusion at this location.
- The vanity shows significant separation at the countertop-to-backsplash junction and at the wall, consistent with movement or loosening of the vanity attachment.
- Staining and possible buildup were noted at the drain junction point. Cleaning or servicing the drain is recommended as a due diligence item.

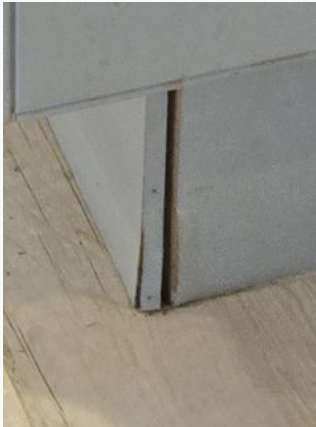
- (I-10) Defects:** Cabinetry adjacent to the fridge showed deformation and separation consistent with moisture exposure. Evaluation was limited to visible areas only, as the appliance was not moved. Conditions behind the appliance were not assessed, and concealed damage may be present.
- Water damage with dark staining was noted inside the drawer, consistent with storing items while wet.
  - The dishwasher drain line is not installed with a high loop, which can allow wastewater to backflow into the dishwasher.

- Corrosion was noted at the faucet supply line (connection from the shutoff valve to the fixture), consistent with seepage at the fitting.
- Separation was noted at the cabinet kick plate.

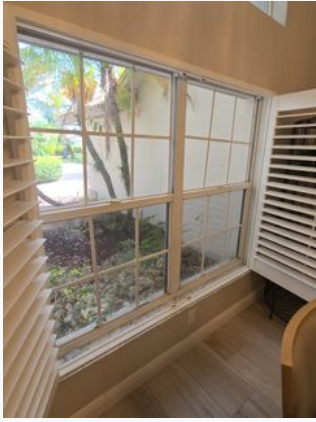
**(I-11) Defects:** The windows (glazed openings) exhibited multiple deficiencies. The windows should be considered as a system with widespread defects.
