Patriot Home Inspections, LLC  
239-826-5866

Nick Brugal, FL State License #HI9057

**Type of Building :** Single Family

**Year of Construction:** 1990

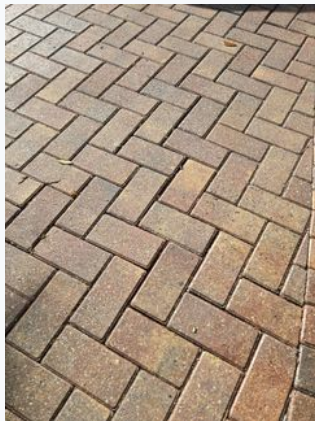
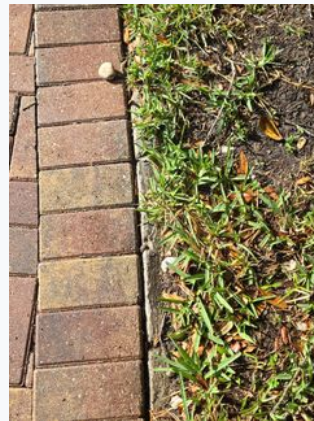
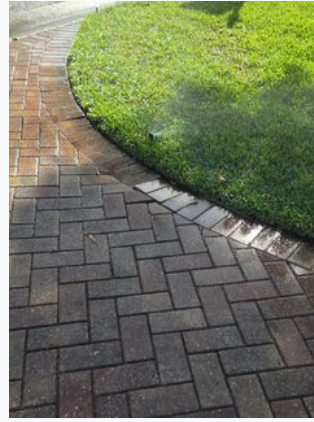
- (E-1) Defects:** Elevation changes and lifting were noted in the pavers at the right side of the home. This appears to be the result of movement in the underlying base material.
- Areas of uneven, lifted, and separated pavers were noted at the driveway in multiple locations.

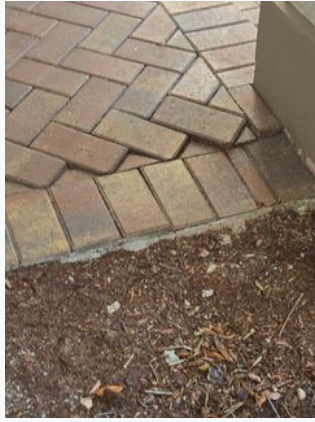
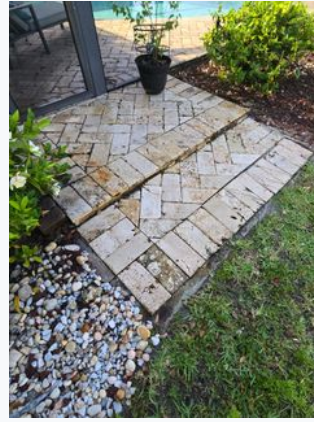
- (E-2) Defects:** Some of the pavers at the front entryway were uneven with elevation changes. This appears to be the result of soil movement.
- Separation of the pavers was noted at the ground-level landing at the right side of the home with retention mortar failure.

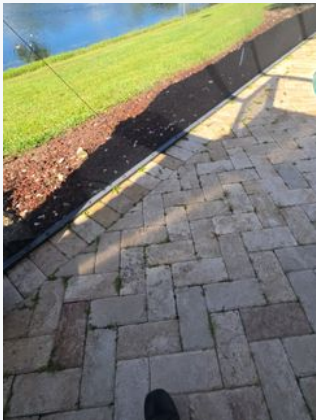
- A large number of weeds were noted in the joints of the pavers. This is a maintenance issue.
- One cracked tile noted at the left rear patio door.

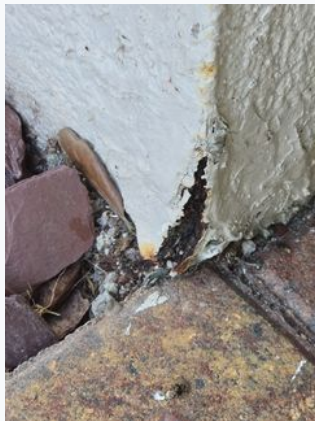
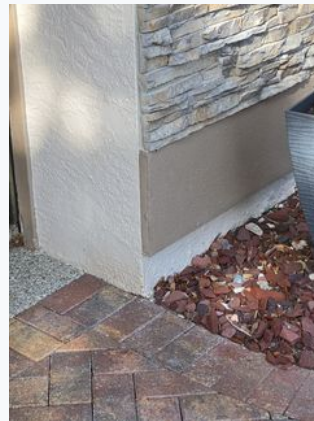
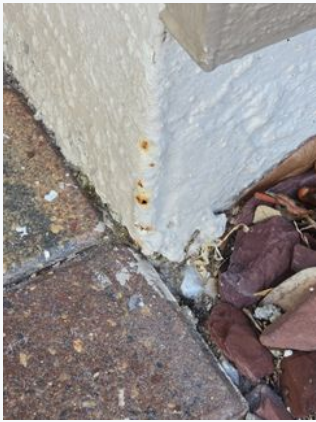
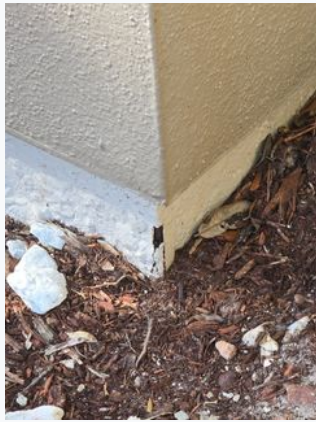
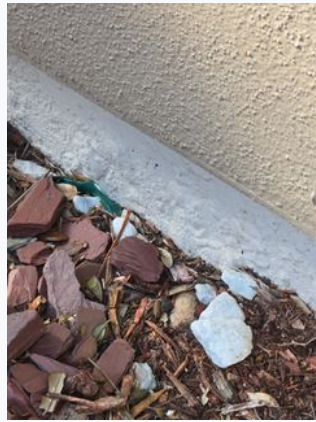
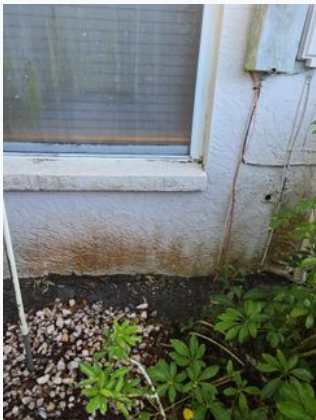
**(E-5) Defects:** Rusting and separation were noted at the metal corner beads behind the stucco

- Paint separation and bubbling were noted at the base of the wall to the right of the garage door, suggesting water exposure at this area.
- Hairline stucco cracking noted at multiple walls. *This condition is commonly associated with normal material shrinkage or minor movement.*

- Patterned cracking noted (step, diagonal, etc), suggesting localized stress from past movement. *This type of cracking is commonly associated with normal material behavior at transitions or concentrated points. Directing water away from the home with gutters and downspout extensions is recommended.*

- The half-wall concealing the trash cans shows signs of material failure, stucco separation, and corner bead rusting/deterioration.
- Multiple areas of stucco separation and corner bead deterioration were noted at the back patio walls near the sliding glass doors and tracks.

- Areas of paint separation noted at the back patio wall.

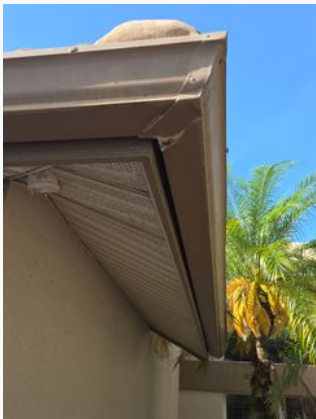
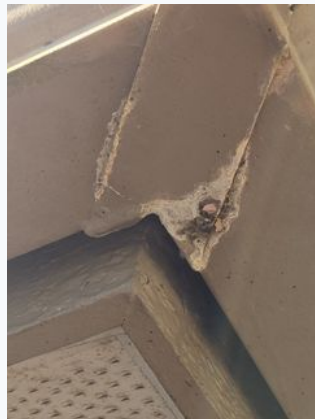
- Evidence of leaking / overflow at gutter(s). *This condition can allow water to roll back beneath the roofing edge or discharge in unintended areas, which may lead to moisture intrusion, deterioration of building materials, or localized erosion over time.*

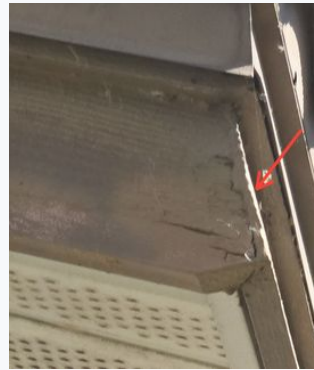
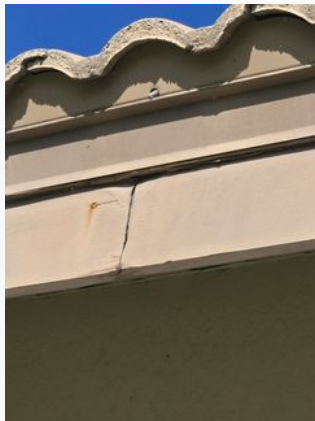
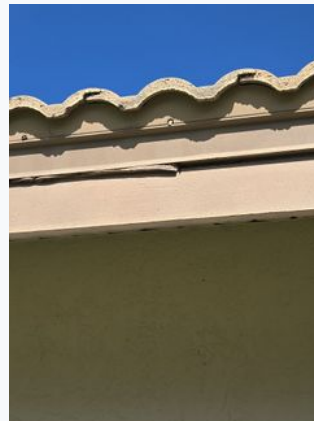
**(E-7) Defects:** Multiple areas of fascia board rot were noted at sides of the home. Further evaluation and correction of the fascia system recommended.

- The soffit near the front entrance of the home has a gap/break. This condition can allow pest intrusion.
- Damage/rot noted in the wood structure of the patio screening at the right side of the home.
- Multiple areas of fascia board rot were noted at the left side of the home. Evaluation was limited to visible areas only. Further evaluation and correction of the fascia system recommended.

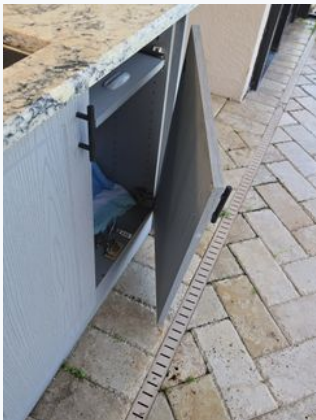
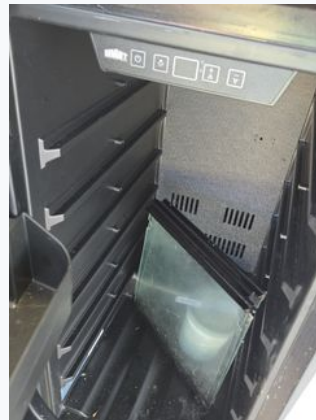
### (E-9) Defects: Built-in Outdoor Kitchen

- One cabinet door was not properly installed.
- The mini fridge was not level and was not operational at the time of inspection.

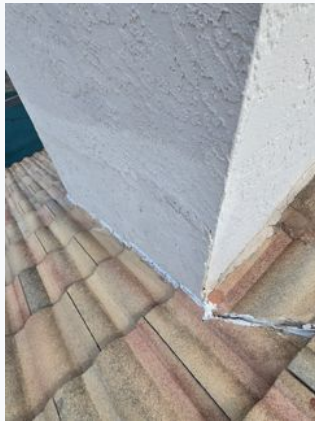
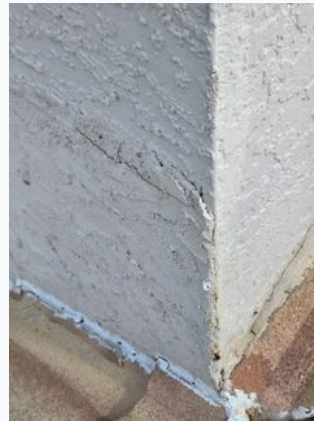
**(E-11) Defects:** The stucco around the chimney shows prior repair with continued deterioration. Chimneys are common leak points. Correction recommended.

- Rusting was noted at the vent cap. Ongoing corrosion can lead to deterioration and leaking.

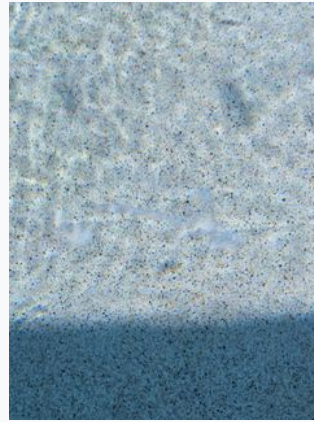
### (E-15) Defects: Walls

- Mineral deposits consistent with calcium scaling were observed on the pool/spa surface. *This is typically a cosmetic condition related to water chemistry and maintenance; however, professional evaluation by a pool specialist is recommended.*
- Heavy calcium buildup was noted on the pool surface. The buildup exceeds typical minor surface scaling and may require professional cleaning or treatment. Further evaluation by a pool professional recommended.

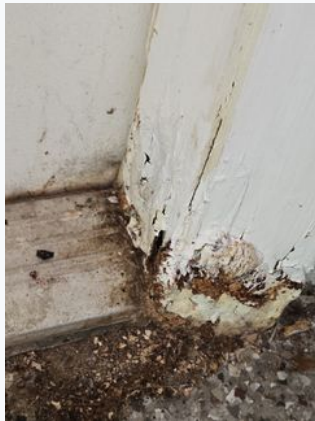
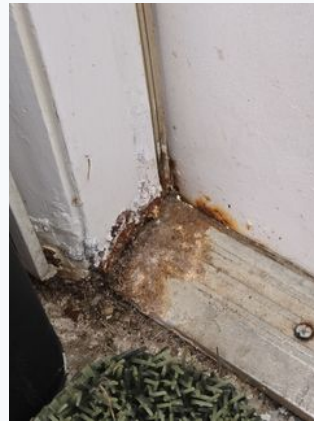
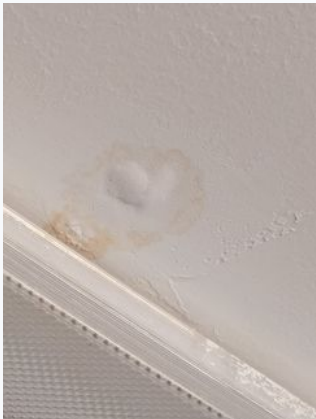
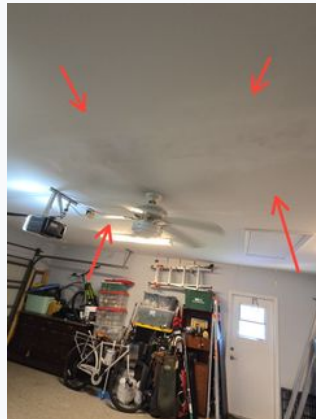
- (I-1) Defects:** Wood rot at the garage side door frame and rusting at the door were noted, indicating prolonged water exposure and water entry.
- The window at the side entry door has been hot glued in place. This is not an appropriate installation/repair method.
  - An area of water staining was noted on the ceiling near the light fixture. The area appears to have been previously patched and has reemerged. The area was dry at the time of inspection.
  - One light did not function.
  - The ceiling beneath the air handler shows prior patching, with water staining observed at the unit consistent with past moisture issues at the air handler.

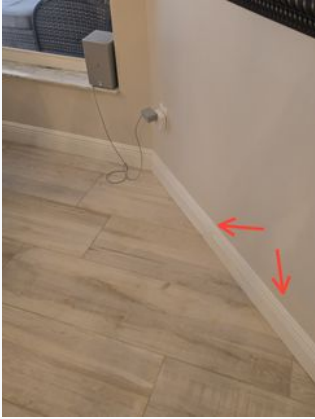
**(I-2) Defects:** Baseboard deformation was noted, consistent with water exposure. The source could not be determined.

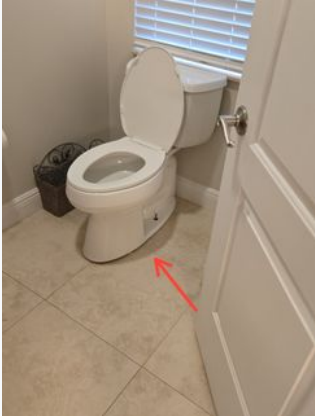
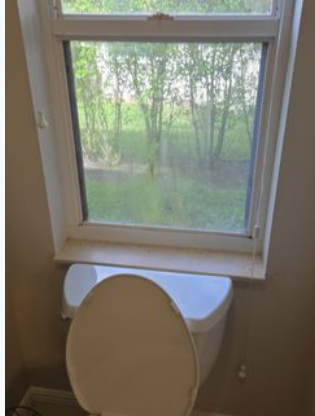
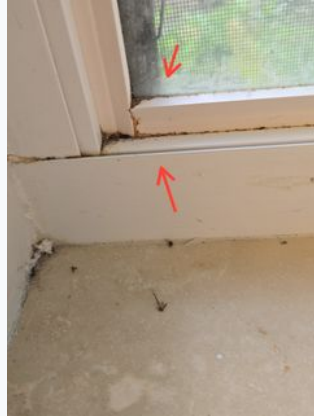
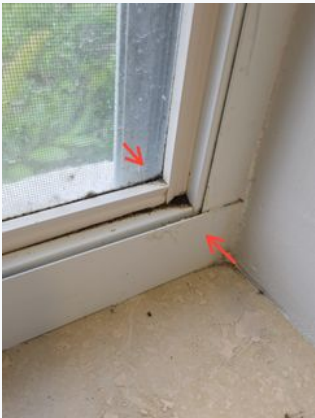
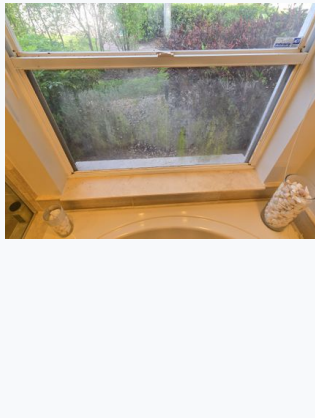
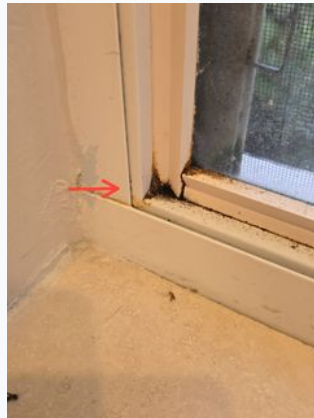
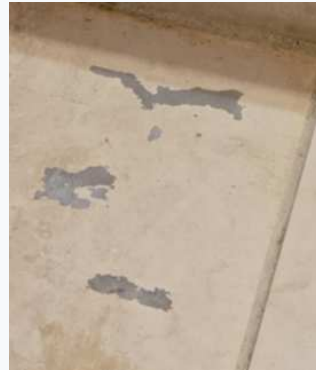
**(I-3) Defects:** The toilet was loose / not properly secured to the floor.

- Multiple windows showed water staining at the frame assemblies, consistent with intrusion at these locations.
- Corrosion buildup noted at both sink drain junction points, consistent with seepage at the connections.
- Corrosion noted at the left sink faucet, consistent with ongoing water exposure at the fixture, likely due to internal leak / failure.
- Water staining / damage at the exterior wall adjacent to the shower. This is consistent with

ongoing exposure from the shower.

- Surface finish deterioration noted at the tile.

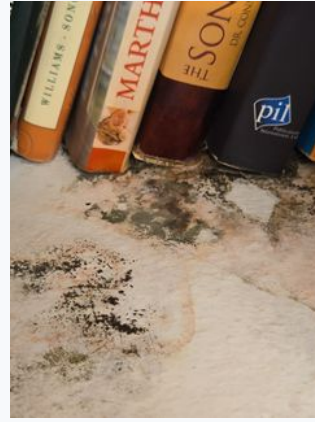
**(I-5) Defects:** Microbial growth was noted inside the cabinetry, consistent with moisture exposure from a stored water container. As a licensed mold remediation professional, the inspector notes that industry standards (IICRC) call for controlled containment and professional remediation, as improper removal can spread spores.

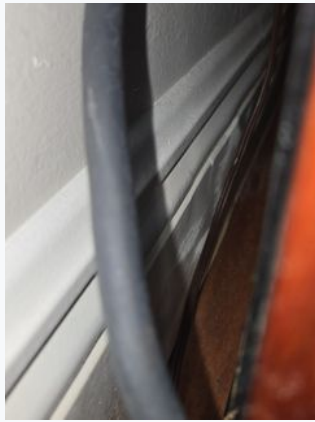
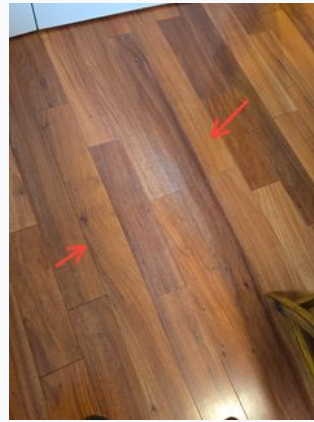
- (I-6) Defects:** Water intrusion was noted at the window assembly, with interior leaking present. Water staining, microbial growth, and baseboard deformation were observed beneath the window, indicating damage from this condition and possible concealed growth within the wall cavity.
- Surface wear noted on the flooring.

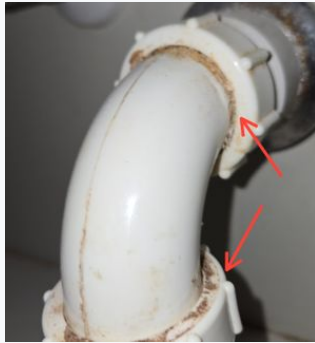
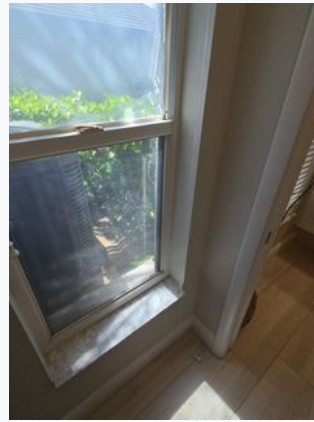
- (I-7) Defects:** Buildup at drain junction points, consistent with minor seepage at the joints.
- Water staining was noted at the window assemblies, consistent with intrusion at these locations.

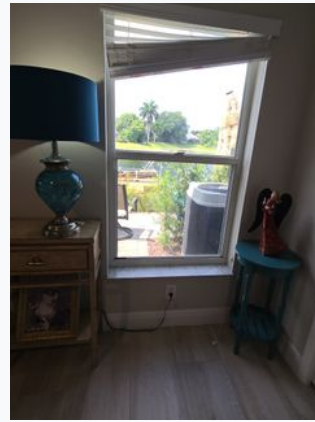
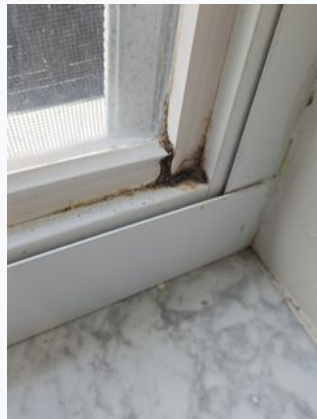
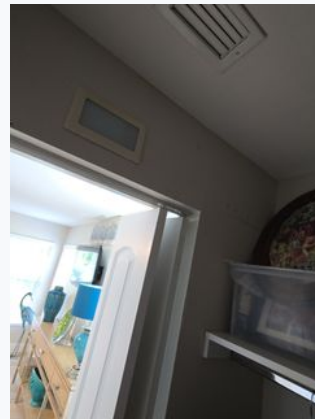
**(I-8) Defects:** The windows displayed multiple defects, including balances out of place, damaged integrated trim, and water staining at the assemblies consistent with intrusion.

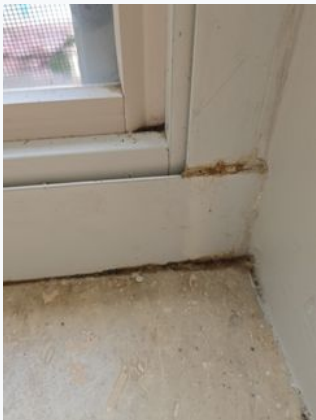
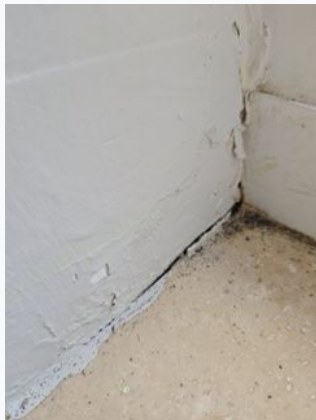
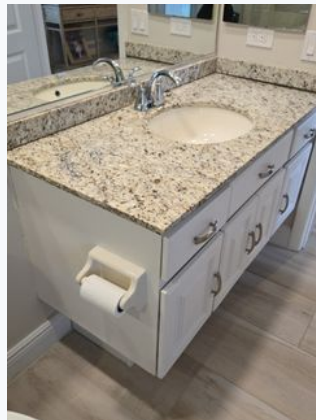
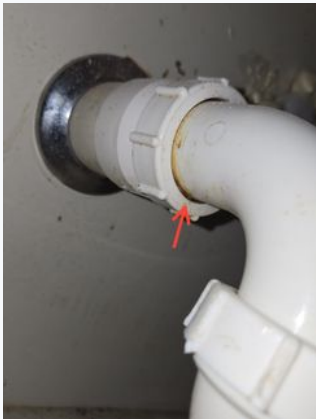
- Water staining was noted at the window assembly with damage to the adjacent drywall, consistent with intrusion at this location.
- The vanity shows significant separation at the countertop-to-backsplash junction and at the wall, consistent with movement or loosening of the vanity attachment.
- Staining and possible buildup were noted at the drain junction point. Cleaning or servicing the drain is recommended as a due diligence item.

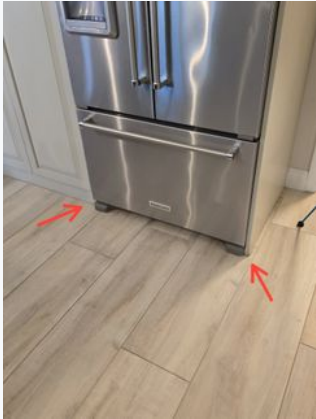
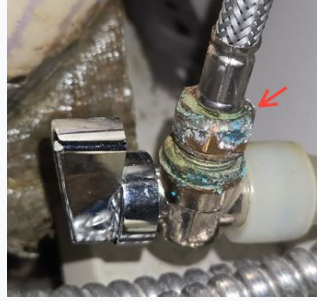
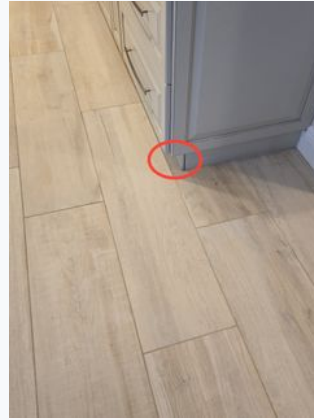
- (I-10) Defects:** Cabinetry adjacent to the fridge showed deformation and separation consistent with moisture exposure. Evaluation was limited to visible areas only, as the appliance was not moved. Conditions behind the appliance were not assessed, and concealed damage may be present.
- Water damage with dark staining was noted inside the drawer, consistent with storing items while wet.
  - The dishwasher drain line is not installed with a high loop, which can allow wastewater to backflow into the dishwasher.

- Corrosion was noted at the faucet supply line (connection from the shutoff valve to the fixture), consistent with seepage at the fitting.
- Separation was noted at the cabinet kick plate.

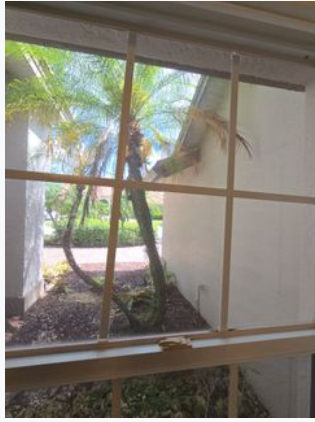
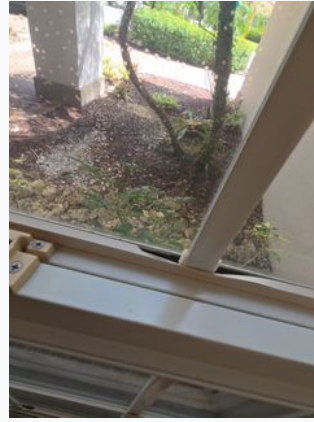
**(I-11) Defects:** The windows (glazed openings) exhibited multiple deficiencies. The windows should be considered as a system with widespread defects.

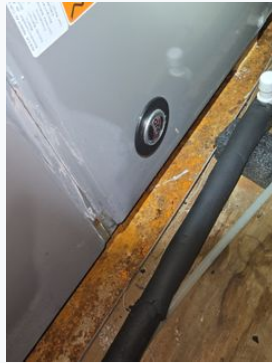
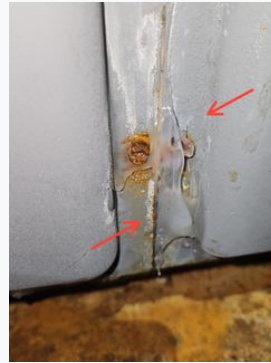
**(S-1) Defects:** The air handler cabinet exterior showed rust and was sealed with adhesive at the seams, indicating ongoing moisture management issues. The condensate pan beneath was

heavily rusted. The sealing appears to be a non-standard repair and limited access to internal components. The ceiling below shows prior patching consistent with past moisture-related damage.

- Water staining was present on the wood decking around the air handler, consisting of both older staining consistent with prior condensate pan issues and more recent staining at the duct plenum connection consistent with active condensation.

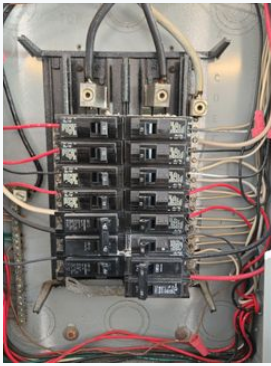
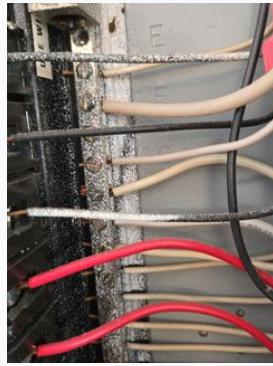
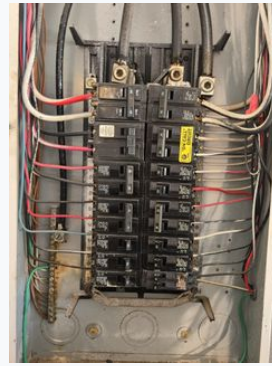
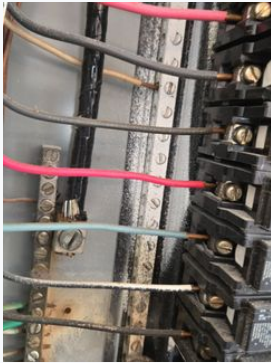
- The smaller panel utilizes several Challenger brand breakers. This brand is known to have reliability issues with tripping. Replacement recommended.

- Paint overspray noted at interior of both breaker panels. *This is considered a technical defect. The interior of an electrical panel is required to be free of foreign matter to prevent potential conductivity issues. The panel functioned as intended at the time of inspection.*

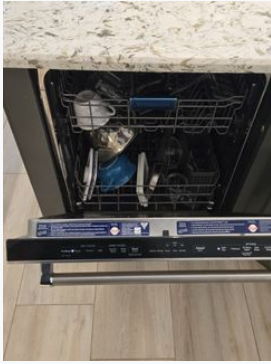
- (S-3) Defects:** The dishwasher was not properly secured and shifted at the sides. Proper securing is recommended.
- The induction cooktop could not be evaluated due to the absence of compatible cookware.

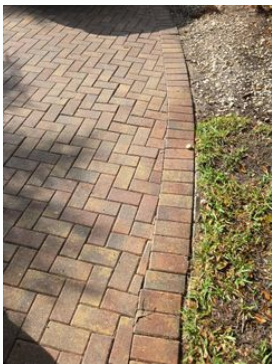
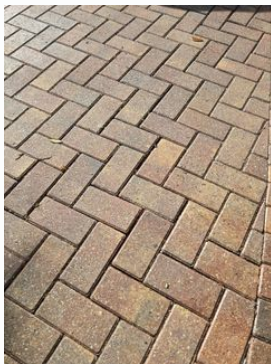
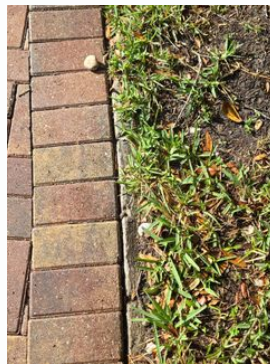
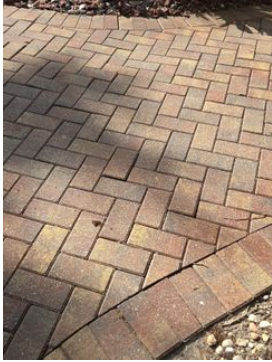
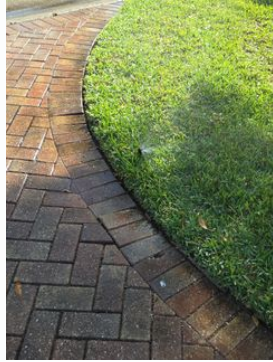
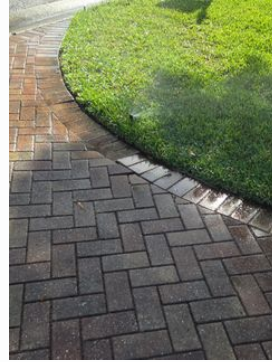
### **E-1 Exterior - Driveway, Patio, Etc:**

- Elevation changes and lifting were noted in the pavers at the right side of the home. This appears to be the result of movement in the underlying base material.
- Areas of uneven, lifted, and separated pavers were noted at the driveway in multiple locations.

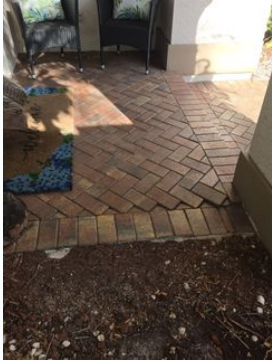
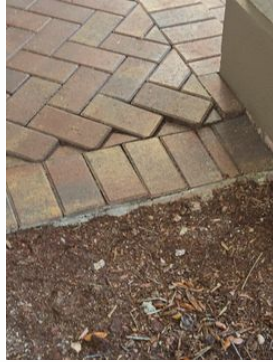
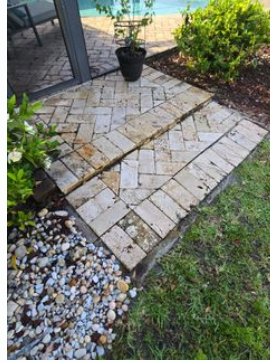
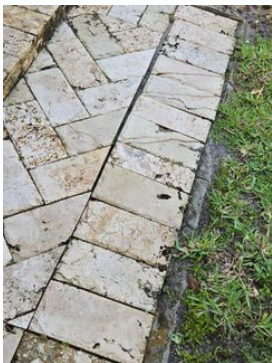
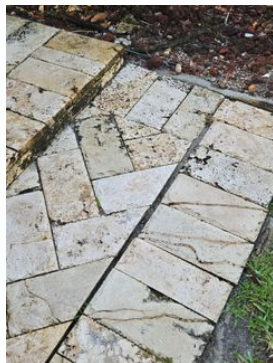
#### **E-2 Exterior - Driveway, Patio, Etc:**

- Some of the pavers at the front entryway were uneven with elevation changes. This appears to be the result of soil movement.
- Separation of the pavers was noted at the ground-level landing at the right side of the home with retention mortar failure.

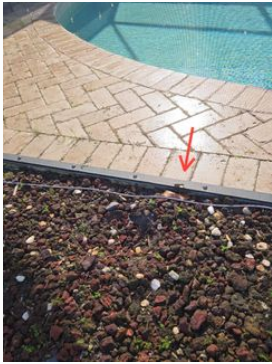
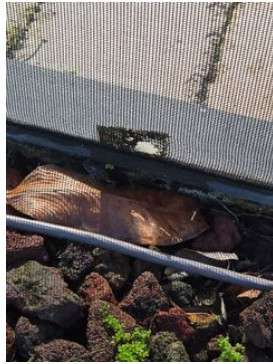
### **E-3 Exterior - Driveway, Patio, Etc:** **Screening**

- Screen damage (minor - cut / puncture / etc)

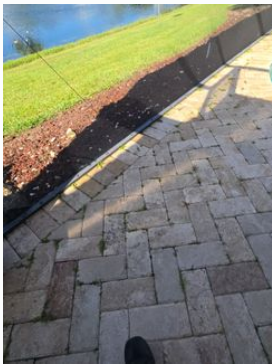
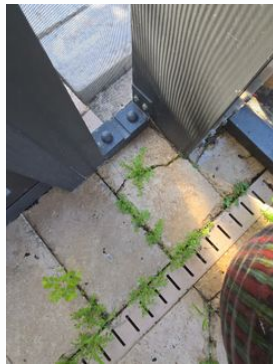
#### **E-4 Exterior - Driveway, Patio, Etc:**

- A large number of weeds were noted in the joints of the pavers. This is a maintenance issue.
- One cracked tile noted at the left rear patio door.

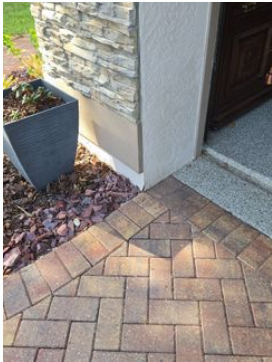
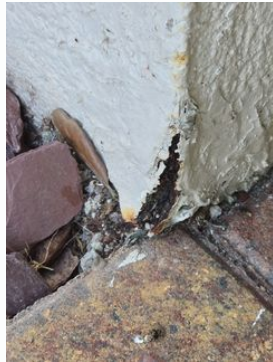
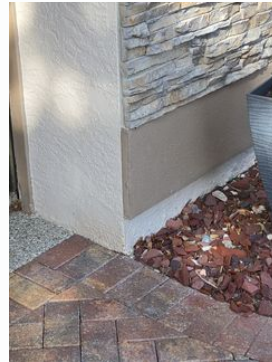
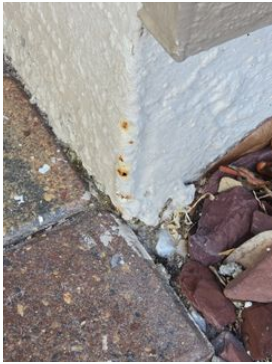
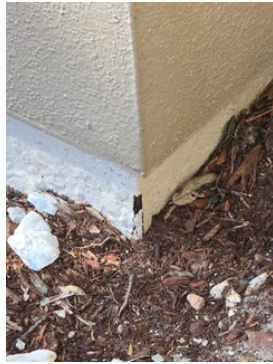
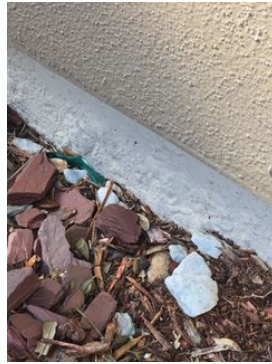
- Rusting and separation were noted at the metal corner beads behind the stucco at the front of the home.
- Paint separation and bubbling were noted at the base of the wall to the right of the

garage door, suggesting water exposure at this area.

- Hairline stucco cracking noted at multiple walls. *This condition is commonly associated with normal material shrinkage or minor movement.*
- Patterned cracking noted (step, diagonal, etc), suggesting localized stress from past movement. *This type of cracking is commonly associated with normal material behavior at transitions or concentrated points. Directing water away from the home with gutters and downspout extensions is recommended.*
- The half-wall concealing the trash cans shows signs of material failure, stucco separation, and corner bead rusting/deterioration.
- Multiple areas of stucco separation and corner bead deterioration were noted at the back patio walls near the sliding glass doors and tracks.
- Areas of paint separation noted at the back patio wall.

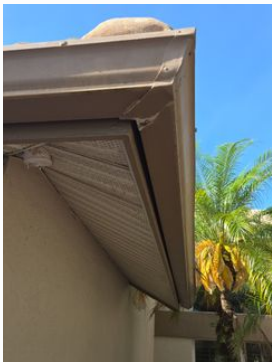
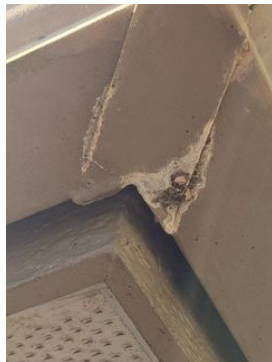
**E-6 Exterior - Exterior - Attached:**  
**Gutters**

- Evidence of leaking / overflow at gutter(s). *This condition can allow water to roll back beneath the roofing edge or discharge in unintended areas, which may lead to moisture intrusion, deterioration of building materials, or localized erosion over time.*

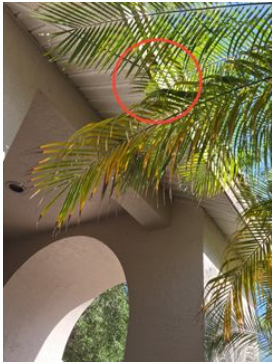
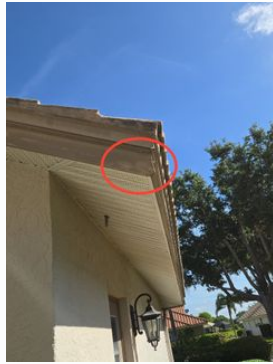
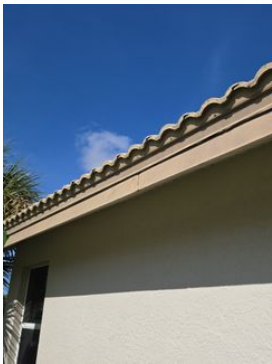
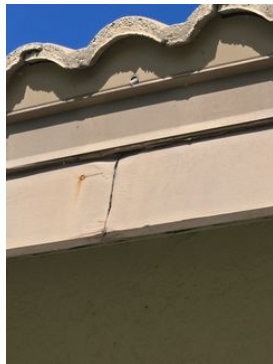
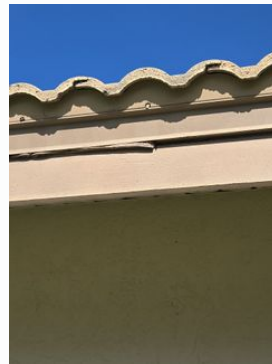
**E-7 Exterior - Exterior - Attached:**

- Multiple areas of fascia board rot were noted at sides of the home. Further evaluation and correction of the fascia system recommended.
- The soffit near the front entrance of the home has a gap/break. This condition can allow pest intrusion.
- Damage/rot noted in the wood structure of the patio screening at the right side of the home.
- Multiple areas of fascia board rot were noted at the left side of the home. Evaluation was limited to visible areas only. Further evaluation and correction of the fascia system recommended.

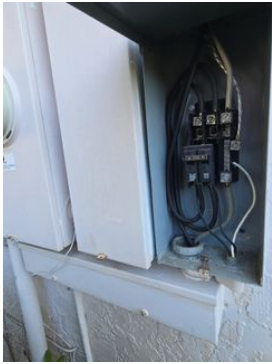
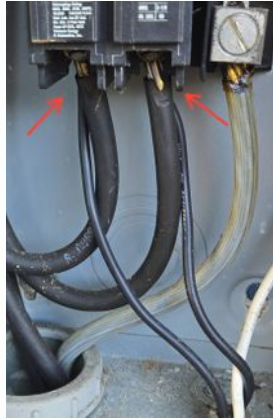
#### **E-8 Exterior - Exterior - Attached:**

- The 100-amp subpanel/disconnect located next to the utility meter has been double-tapped with the surge protector wiring. Multiple conductors under a terminal not rated for more than one conductor can result in a loose connection and overheating. Correction recommended.

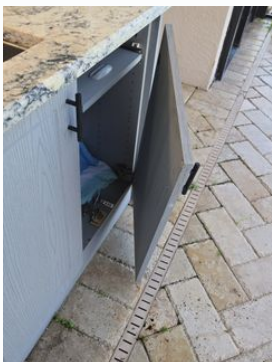
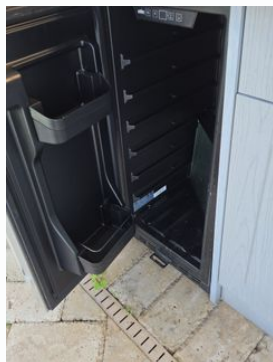
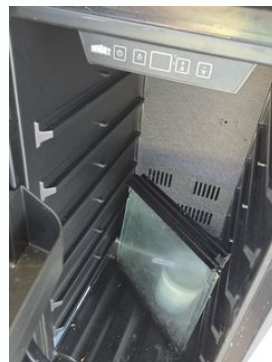
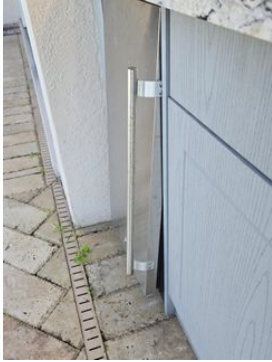
**E-9 Exterior - Exterior - Attached:  
Built-in Outdoor Kitchen**

- One cabinet door was not properly installed.
- The mini fridge was not level and was not operational at the time of inspection.

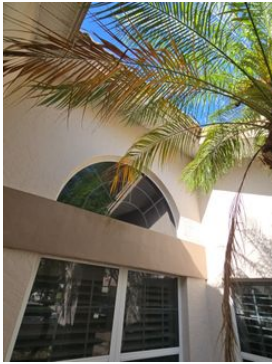
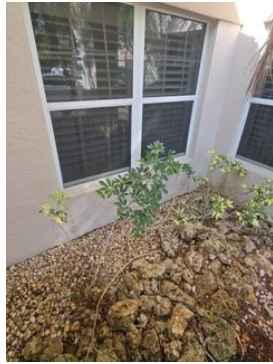
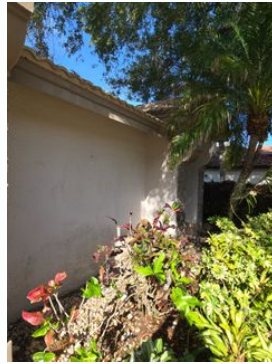
#### **E-10 Exterior - Yard / Site Features:**

- Due to the roof design some areas do not have gutters resulting in rainwater discharging directly to the ground below, causing splashback at the wall. Rock has been installed in this area to reduce erosion and water splash. This is not considered a functional defect, but noted for your information.
- A large oak tree at the front right side of the home has branches contacting the roof and roots interacting with the driveway. Trimming of the branches and evaluation of the root interaction is recommended.
- At the left-back side of the home, an area of erosion and a pile of concrete were noted against the wall with stucco differences. The reason for this condition is unknown. Further investigation warranted.

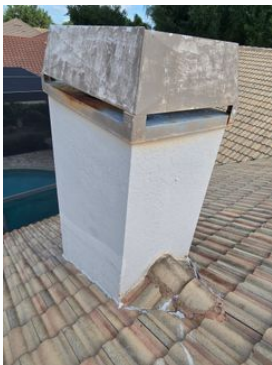
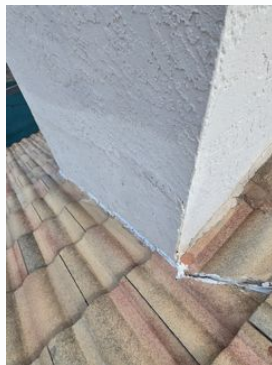
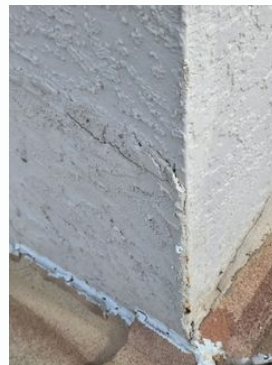
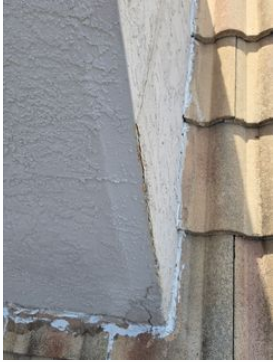
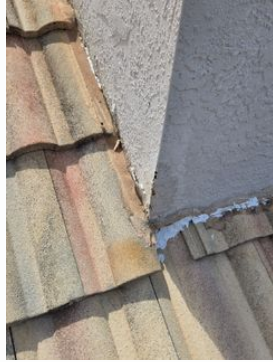
#### **E-11 Exterior - Yard / Site Features:**

- The stucco around the chimney shows prior repair with continued deterioration. Chimneys are common leak points. Correction recommended.
- Rusting was noted at the vent cap. Ongoing corrosion can lead to deterioration and leaking.

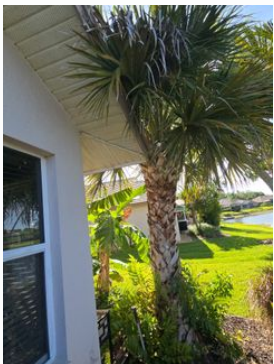
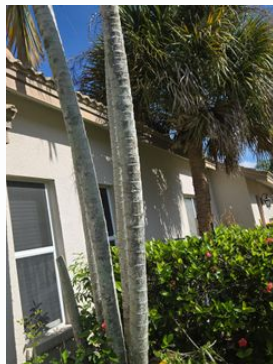
### **E-12 Exterior - Yard / Site Features:**

- Plants come in contact with the exterior wall. All plants should be cut back at least one foot from the wall as a best practice.
- Tree branches overhanging the roof surface. Overhanging branches can provide a pathway for rodents and other pests to access the attic. It is recommended to trim all tree branches at least 2 feet away from the roofline.

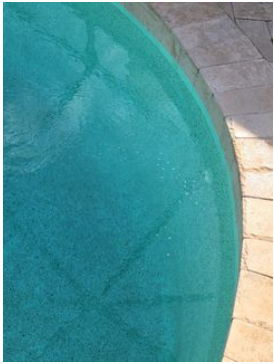
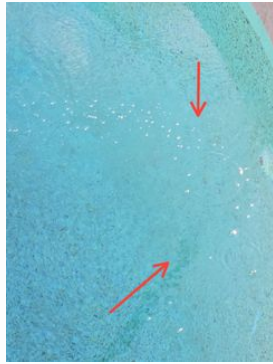
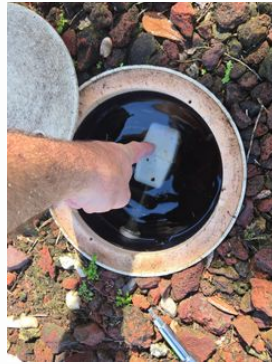
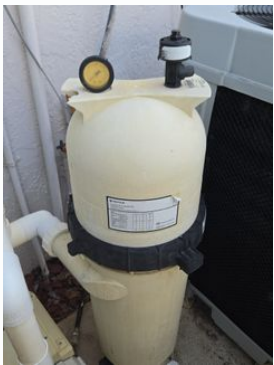
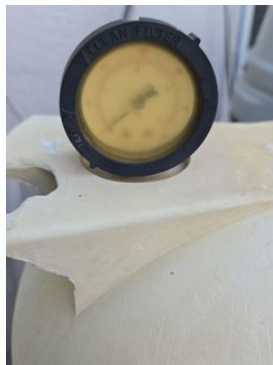
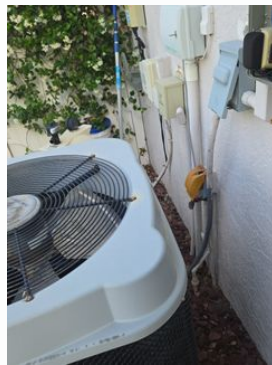
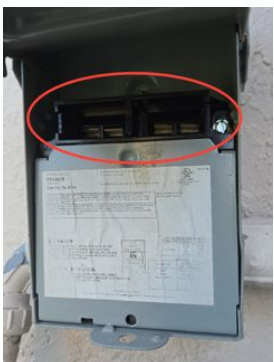
#### **E-14 Exterior - Pool:** **Pool Heater**

- The pool heater was disconnected at the disconnect box. The pull-out handle/bar required to energize the disconnect was missing. The pool heater was not tested and functionality is unknown.

- Air bubbles were observed at one or more pool inlets. *This condition is typically associated with air entering the system on the suction side, commonly at the pump, fittings, or valves.*

- Auto-fill system did not operate during testing.

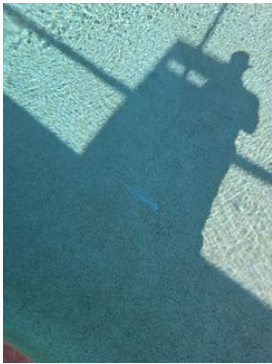
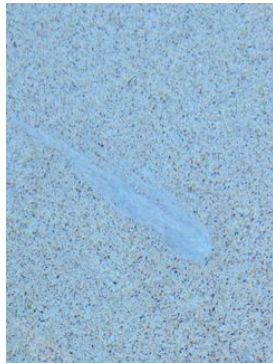
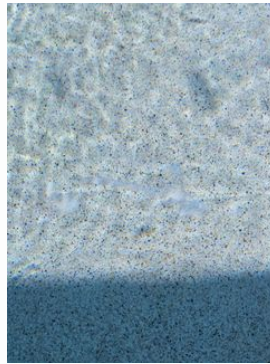
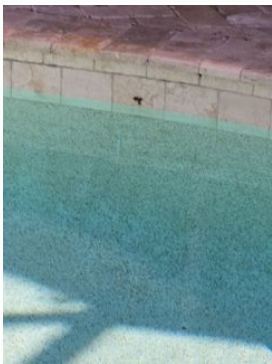
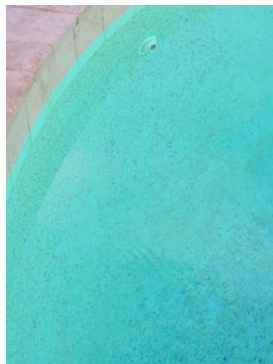
## **E-15 Exterior - Pool:**

- Mineral deposits consistent with calcium scaling were observed on the pool/spa surface. *This is typically a cosmetic condition related to water chemistry and maintenance; however, professional evaluation by a pool specialist is recommended.*
- Heavy calcium buildup was noted on the pool surface. The buildup exceeds typical minor surface scaling and may require professional cleaning or treatment. Further evaluation by a pool professional recommended.

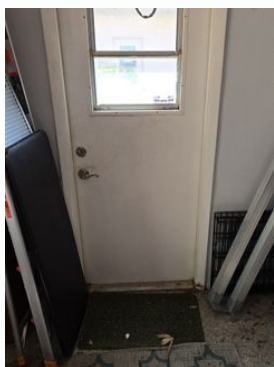
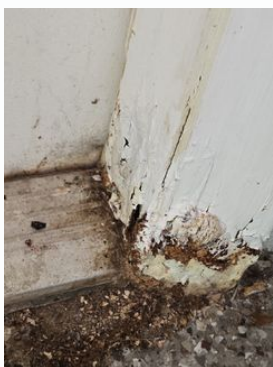
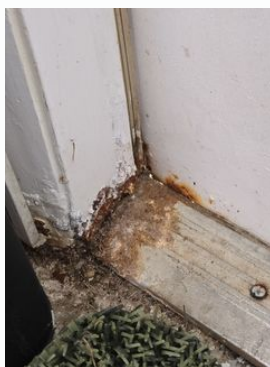
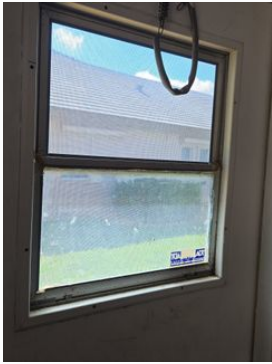
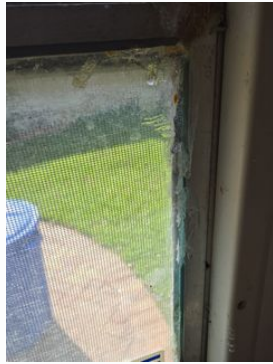
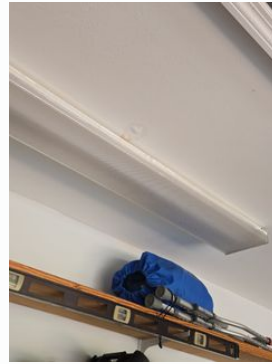
### **I-1 Interior - Garage:**

- Wood rot at the garage side door frame and rusting at the door were noted, indicating prolonged water exposure and water entry.
- The window at the side entry door has been hot glued in place. This is not an appropriate installation/repair method.
- An area of water staining was noted on the ceiling near the light fixture. The area appears to have been previously patched and has reemerged. The area was dry at the time of inspection.
- One light did not function.
- The ceiling beneath the air handler shows prior patching, with water staining observed at the unit consistent with past moisture issues at the air handler.

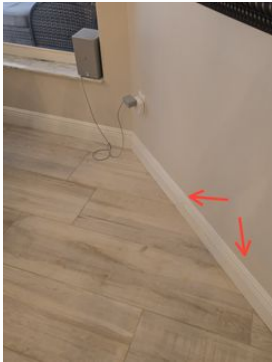
## **I-2 Interior - Kitchen Dining:**

- Baseboard deformation was noted, consistent with water exposure. The source could not be determined.

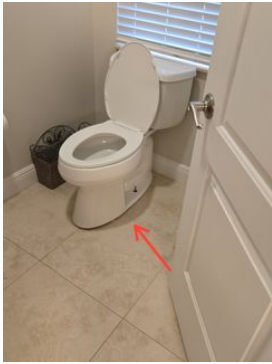
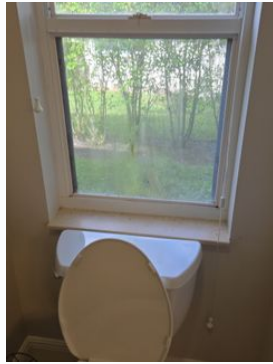
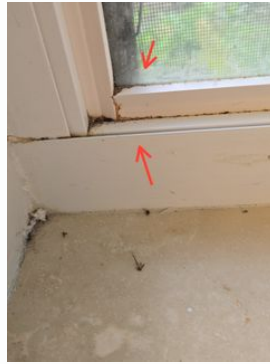
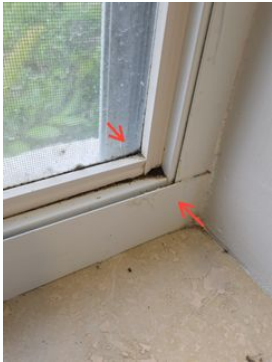
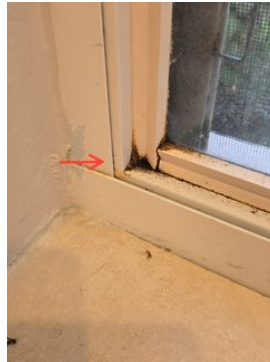
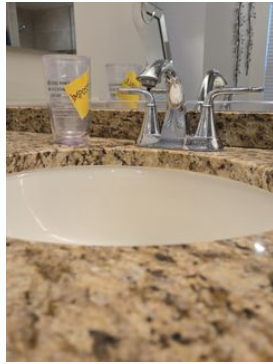
### **I-3 Interior - Master Bathroom:**

- The toilet was loose / not properly secured to the floor.
- Multiple windows showed water staining at the frame assemblies, consistent with intrusion at these locations.
- Corrosion buildup noted at both sink drain junction points, consistent with seepage at the connections.
- Corrosion noted at the left sink faucet, consistent with ongoing water exposure at the fixture, likely due to internal leak / failure.
- Water staining / damage at the exterior wall adjacent to the shower. This is consistent with ongoing exposure from the shower.
- Surface finish deterioration noted at the tile.

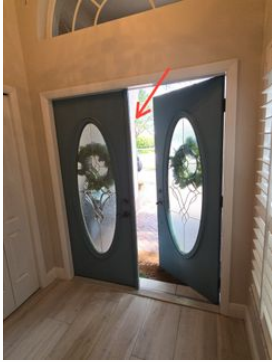
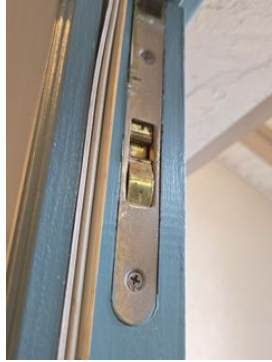
#### **I-4 Interior - Entryway:**

- The pin lock at the support French door does not disengage.

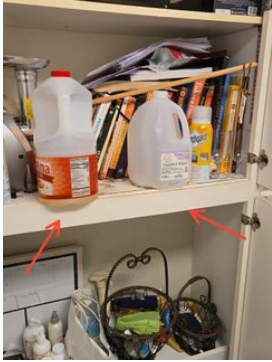
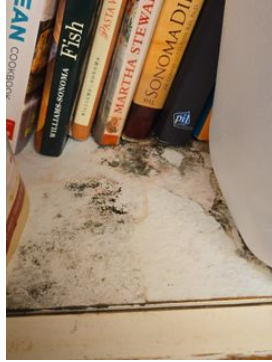
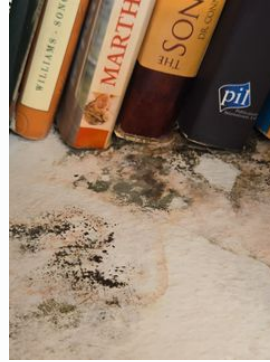
#### **I-5 Interior - Laundry Room:**

- Microbial growth was noted inside the cabinetry, consistent with moisture exposure from a stored water container. As a licensed mold remediation professional, the inspector notes that industry standards (IICRC) call for controlled containment and professional remediation, as improper removal can spread spores.

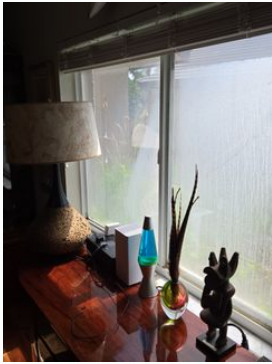
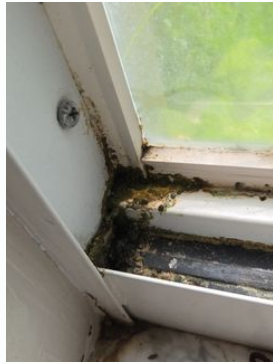
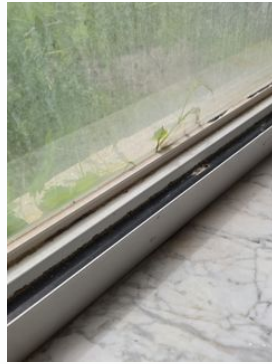
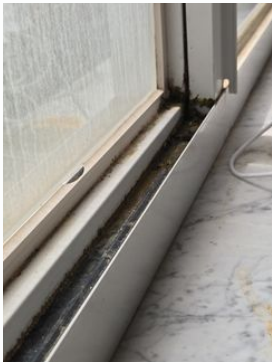
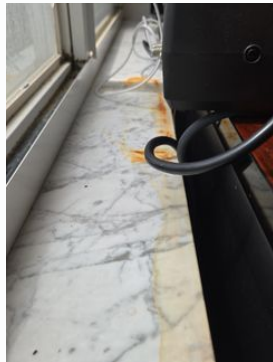
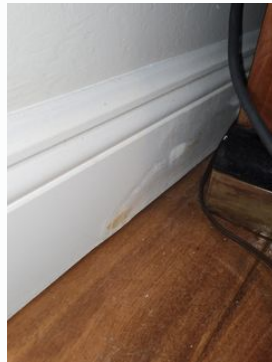
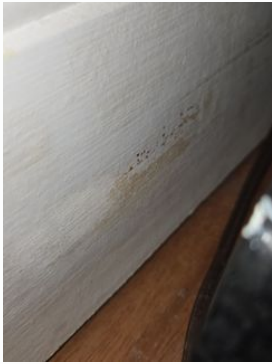
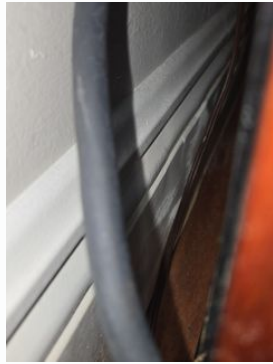
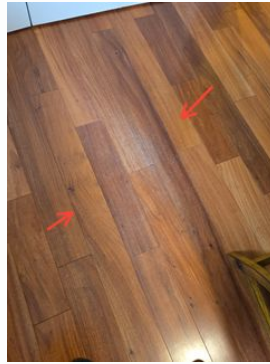
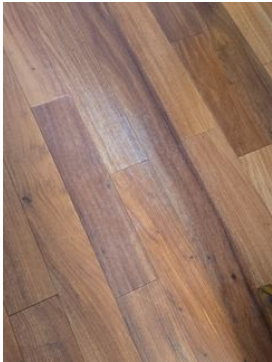
#### **I-6 Interior - Office:**

- Water intrusion was noted at the window assembly, with interior leaking present. Water staining, microbial growth, and baseboard deformation were observed beneath the window, indicating damage from this condition and possible concealed growth within the wall cavity.
- Surface wear noted on the flooring.

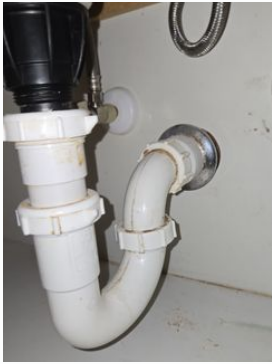
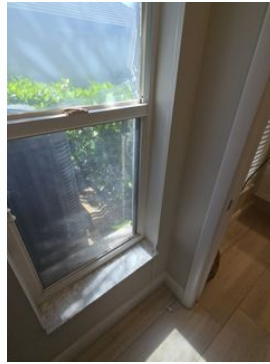
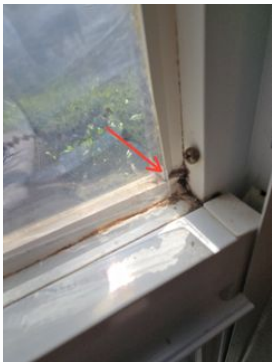
#### **I-7 Interior - Guest Bathroom :**

- Buildup at drain junction points, consistent with minor seepage at the joints.
- Water staining was noted at the window assemblies, consistent with intrusion at these locations.

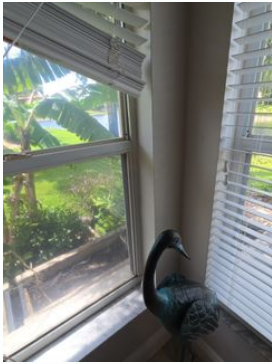
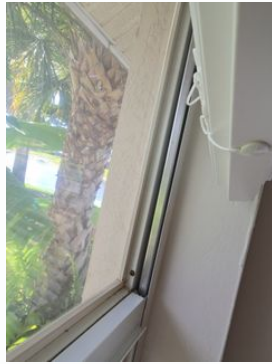
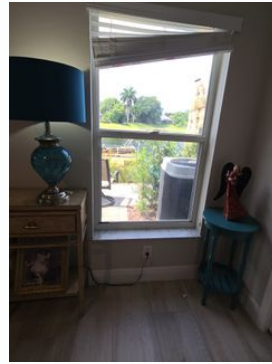
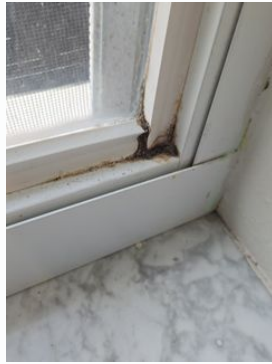
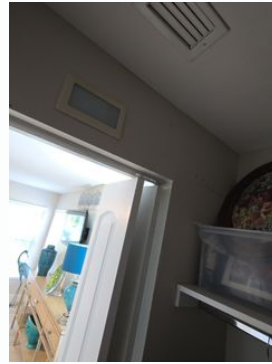
### **I-8 Interior - Pool Guest:**

- The windows displayed multiple defects, including balances out of place, damaged integrated trim, and water staining at the assemblies consistent with intrusion.

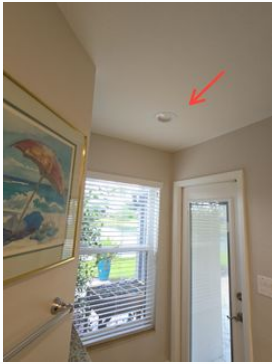
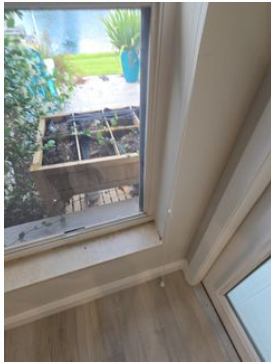
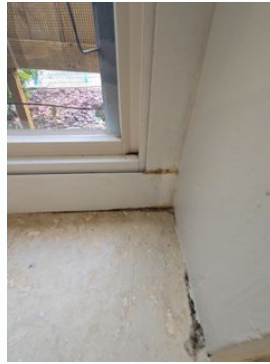
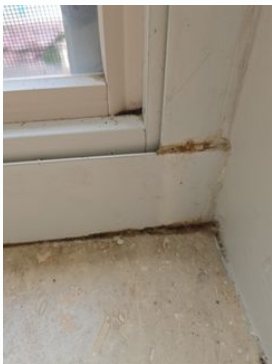
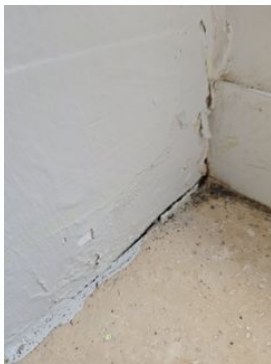
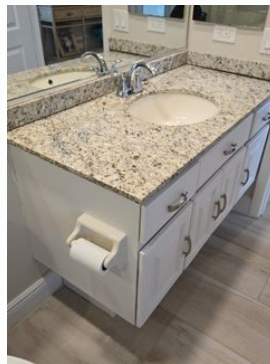
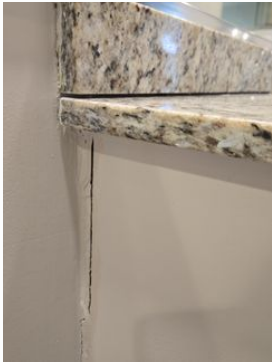
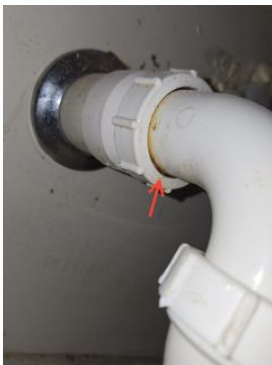
### **I-9 Interior - Poolside Bathroom:**

- The light near the patio door did not function.
- Water staining was noted at the window assembly with damage to the adjacent drywall, consistent with intrusion at this location.
- The vanity shows significant separation at the countertop-to-backsplash junction and at the wall, consistent with movement or loosening of the vanity attachment.
- Staining and possible buildup were noted at the drain junction point. Cleaning or servicing the drain is recommended as a due diligence item.

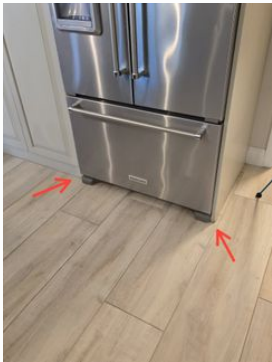
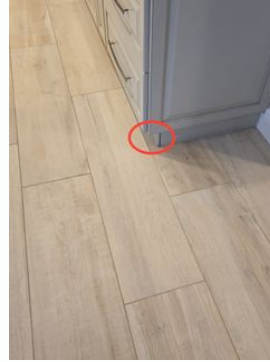
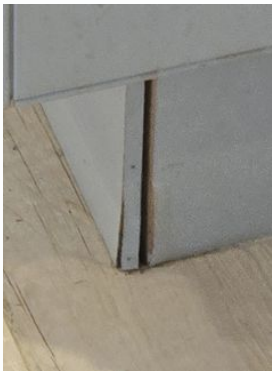
#### **I-10 Interior - Kitchen:**

- Cabinetry adjacent to the fridge showed deformation and separation consistent with moisture exposure. Evaluation was limited to visible areas only, as the appliance was not moved. Conditions behind the appliance were not assessed, and concealed damage may be present.
- Water damage with dark staining was noted inside the drawer, consistent with storing items while wet.
- The dishwasher drain line is not installed with a high loop, which can allow wastewater to backflow into the dishwasher.
- Corrosion was noted at the faucet supply line (connection from the shutoff valve to the fixture), consistent with seepage at the fitting.

- Separation was noted at the cabinet kick plate.
