Patriot Home Inspections, LLC  
239-826-5866

Nick Brugal, FL State License #HI9057

**Type of Building :** Single Family

**Year of Construction:** 1990

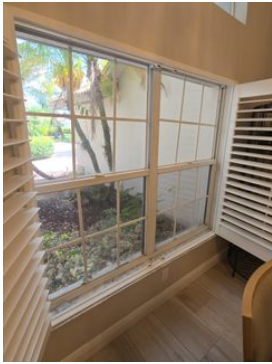
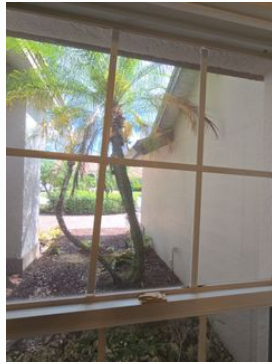
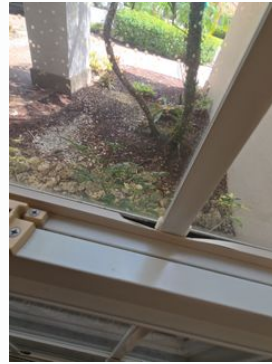
### **I-11 Interior - General / Multiples:**

- The windows (glazed openings) exhibited multiple deficiencies. The windows should be considered as a system with widespread defects.

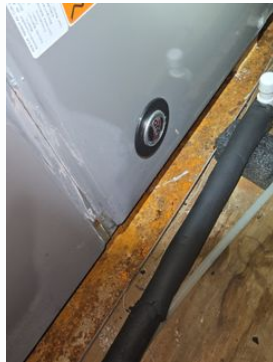
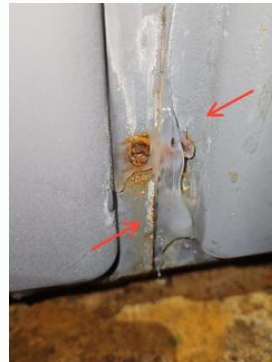
- The air handler cabinet exterior showed rust and was sealed with adhesive at the seams, indicating ongoing moisture management issues. The condensate pan beneath was heavily rusted. The sealing appears to be a non-standard repair and limited access to internal components. The ceiling below shows prior patching consistent with past moisture-related damage.
- Water staining was present on the wood decking around the air handler, consisting of both older staining consistent with prior condensate pan issues and more recent staining

at the duct plenum connection consistent with active condensation.

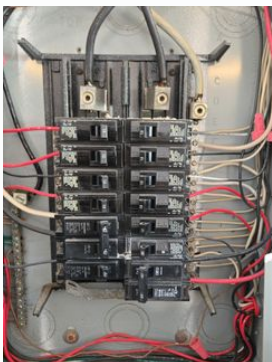
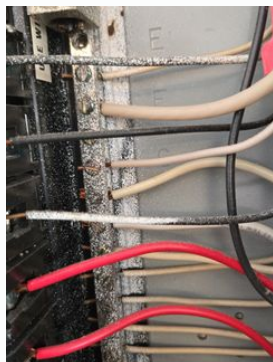
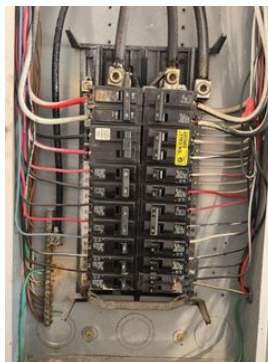
### **Paint / Foreign Object**

- The smaller panel utilizes several Challenger brand breakers. This brand is known to have reliability issues with tripping. Replacement recommended.

- Paint overspray noted at interior of both breaker panels. *This is considered a technical defect. The interior of an electrical panel is required to be free of foreign matter to prevent potential conductivity issues. The panel functioned as intended at the time of inspection.*

Further evaluation and correction recommended for all items.

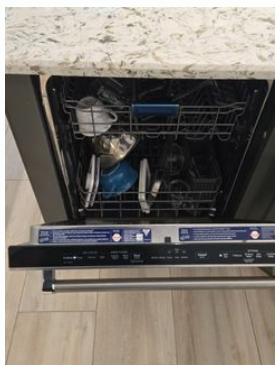
### **S-3 Systems - Appliances :**

- The dishwasher was not properly secured and shifted at the sides. Proper securing is recommended.
- The induction cooktop could not be evaluated due to the absence of compatible cookware.
